Access Compliance Report

Public Rights-of-Way

(Curb Ramps)

| Intersection ID: 11812 | Main Street: EASTWAY_DR | Cross Street: DUNLAVIN_WY | Location: SW |

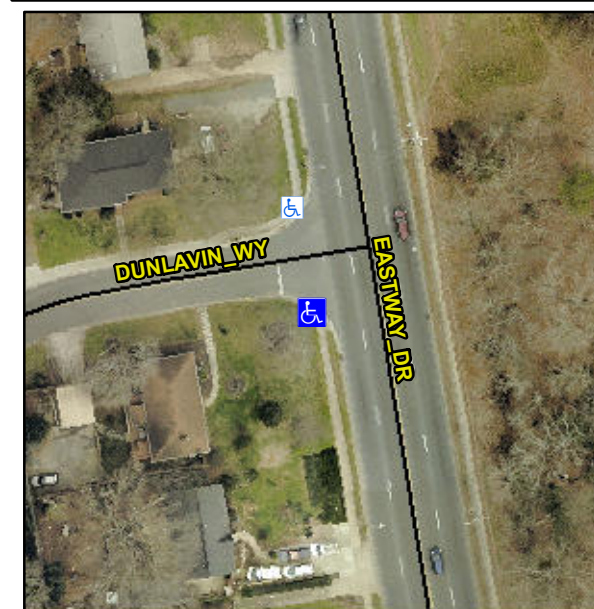
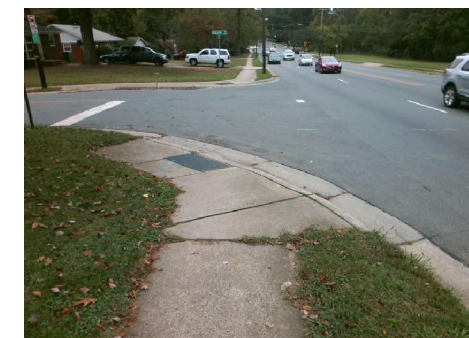
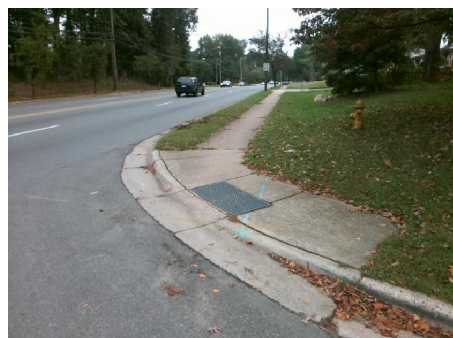
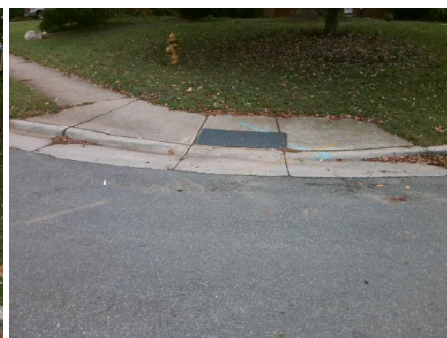
| ADA ID: CC81291D2016 | Ramp Type: Perp | Initial Pass/Fail: Fail | Overall Compliance: No |

Not Found, R304.5.1, R304.5.3

| Compliance | Description | Data | Compliance | Description | Data |
|---|---|---|---|---|---|
| N/A | Ramp Length (in) | 58.0 | Yes | Ramp Slope (%) | 6.8 |
| No | Ramp Width (in) | 44.0 | No | Ramp XSlope (%) | 7.7 |

Possible Solutions:

Remove & Replace Entire Ramp.

Total Cost: \$ 1850.00
