Access Compliance Report

Public Rights-of-Way

(Curb Ramps)

| Intersection ID: 18726 | Main Street: TYVOLA_RD | Cross Street: OLD_PINEVILLE_RD | Location: SW |

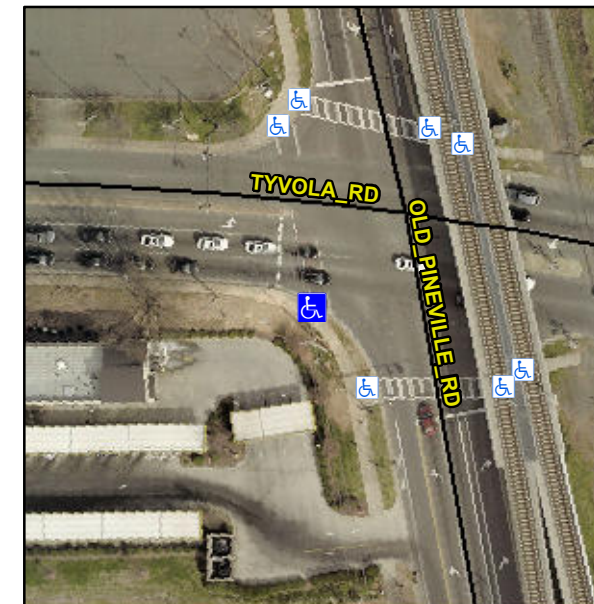
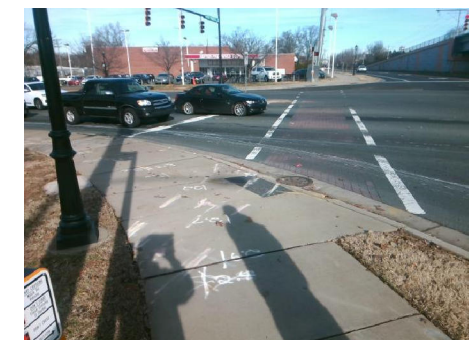
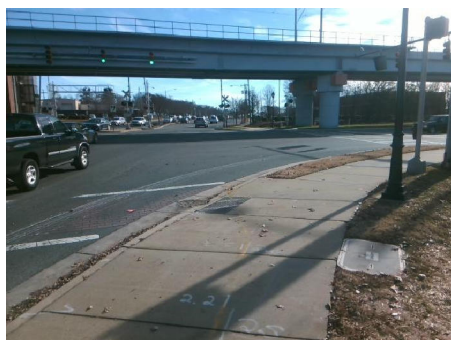
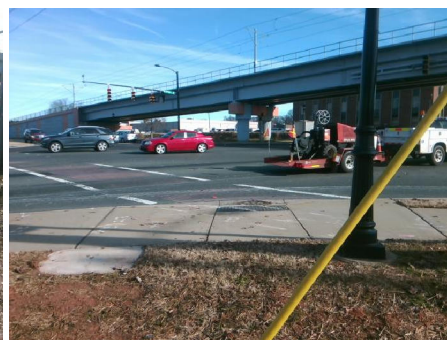
| ADA ID: CC916F78E265 | Ramp Type: Perp | Initial Pass/Fail: Fail | Overall Compliance: No |

R304.5.1, R304.5.3

| Compliance | Description | Data | Compliance | Description | Data |
|---|---|---|---|---|---|
| N/A | Ramp Length (in) | 105.0 | Yes | Ramp Slope (%) | 5.2 |
| No | Ramp Width (in) | 44.0 | No | Ramp XSlope (%) | 5.0 |

Remove & Replace Entire Ramp.
