# Access Compliance Report

## Public Rights-of-Way

### (Curb Ramps)

| Intersection ID: 10074 | Main Street: KILDARE_DR | Cross Street: OLINDA_ST | Location: | N |

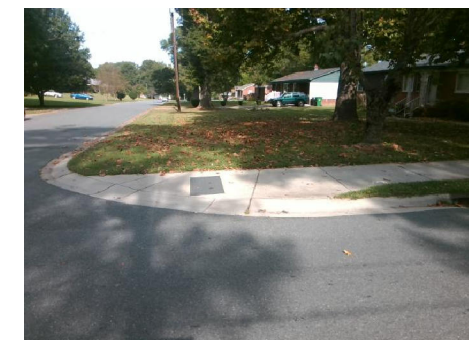
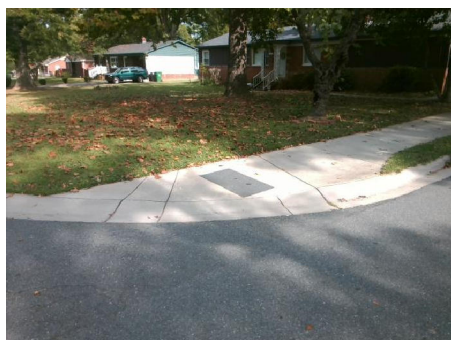
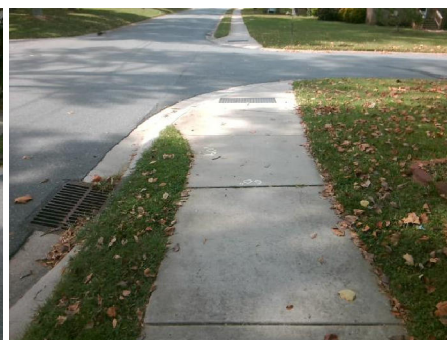
| ADA ID: CC96538A3007 | Ramp Type: Directional1 | Initial Pass/Fail: Pass | Overall Compliance: No | Severity Score: 15 |

**Not Found, R304.2.2-Perp, R304.3.2-  
Para, R305.1.4, R305.2, R302.7.2,  
R304.5.4**

| Compliance | Description | Data | Compliance | Description | Data |
|---|---|---|---|---|---|
| No | Landing Slope (%) | 2.1 | Yes | DWS Length (in) | 24.0 |
| Yes | Landing X Slope (%) | 3.0 | No | DWS Full Width? | No |
| Yes | Gutter Ponding? | No | No | Gutter Slope (%) | 5.7 |
| No | Gutter Lip Ht (in) | 0.5 | Yes | Gutter X Slope (%) | 3.5 |

**Remove & Replace Entire Ramp.  
Remove & Replace Gutter.**
