Access Compliance Report

Public Rights-of-Way

(Curb Ramps)

Intersection ID: 13779	Main Street: CENTRAL_AV	Cross Street: MEDFORD_DR	Location: NE
ADA ID: CC9FD4F95C4B	Ramp Type: Perp	Initial Pass/Fail: Fail	Overall Compliance: No
		Severity Score: 10

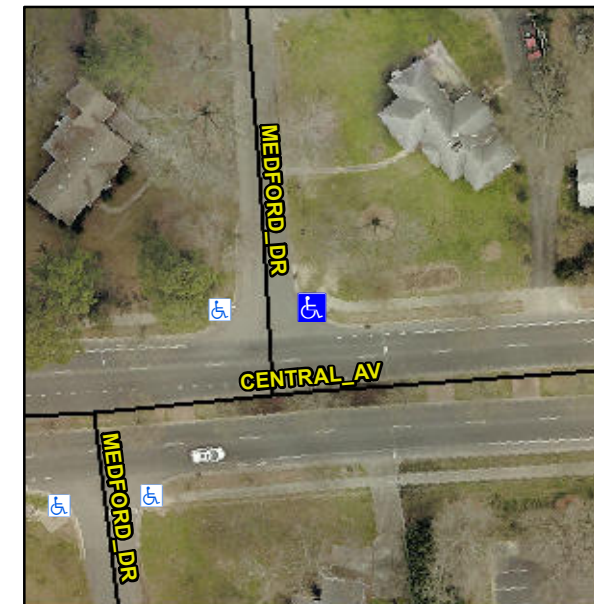
Not Found, R304.5.1, R304.5.3

Compliance	Description	Data	Compliance	Description	Data
N/A	Ramp Length (in)	72.0	Yes	Ramp Slope (%)	7.1
No	Ramp Width (in)	37.5	No	Ramp XSlope (%)	3.7
N/A	Flare Type LT	N/A	N/A	Flare Type RT	N/A
N/A	Flare Slope LT (%)	N/A	N/A	Flare Slope RT (%)	N/A
N/A	Flare Traversable LT?	N/A	N/A	Flare Traversable RT?	N/A
N/A	Landing Length (in)	N/A	N/A	DWS Provided?	N/A
N/A	Landing Width (in)	N/A	N/A	DWS Contrast?	N/A
N/A	Landing Slope (%)	N/A	N/A	DWS Length (in)	N/A
N/A	Landing X Slope (%)	N/A	N/A	DWS Full Width?	N/A
N/A	Landing Curb? (Y/N)	N/A	N/A	DWS Offset (in)	N/A
N/A	Shared Landing?	N/A			
N/A	Gutter Ponding?	N/A	N/A	Gutter Slope (%)	N/A
N/A	Gutter Lip Ht (in)	N/A	N/A	Gutter X Slope (%)	N/A
N/A	Painted X Walk1?	No	N/A	Painted X Walk2?	N/A
	X Walk 1 Direction	To W		X Walk 2 Direction	N/A
N/A	X Walk 1 Width (in)	N/A	N/A	X Walk 2 Width (in)	N/A
	X Walk 1 Slope (%)	1.4		X Walk 2 Slope (%)	N/A
	X Walk 1 X Slope (%)	3.3		X Walk 2 X Slope (%)	N/A

Remove & Replace Entire Ramp.

Total Cost: \$ 1850.00
