Access Compliance Report

Public Rights-of-Way

(Curb Ramps)

Intersection ID: 48463	Main Street: PANGLEMONT_DR	Cross Street: CHANDLER_HAVEN_DR	Location: S
ADA ID: CCA6E1F771EE	Ramp Type: PerpDiag	Initial Pass/Fail: Fail	Overall Compliance: No
Severity Score: 22.5			
Codes/Mitigation Info/Possible Solution		Field Measurements/Component Compliance

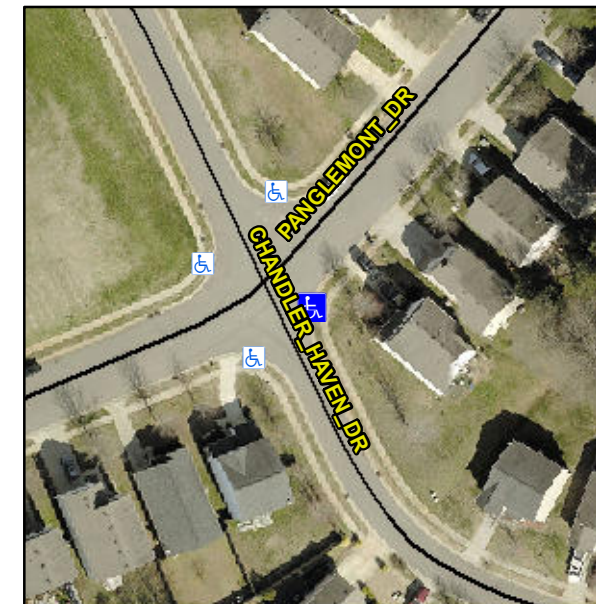
Not Found, R304.5.1, R304.2.2, R304.5.3

Compliance	Description	Data	Compliance	Description	Data
N/A	Ramp Length (in)	48.0	No	Ramp Slope (%)	11.9
No	Ramp Width (in)	47.0	No	Ramp XSlope (%)	2.5
N/A	Flare Type LT	N/A	N/A	Flare Type RT	N/A
N/A	Flare Slope LT (%)	N/A	N/A	Flare Slope RT (%)	N/A
N/A	Flare Traversable LT?	N/A	N/A	Flare Traversable RT?	N/A
N/A	Landing Length (in)	N/A	N/A	DWS Provided?	N/A
N/A	Landing Width (in)	N/A	N/A	DWS Contrast?	N/A
N/A	Landing Slope (%)	N/A	N/A	DWS Length (in)	N/A
N/A	Landing X Slope (%)	N/A	N/A	DWS Full Width?	N/A
N/A	Landing Curb? (Y/N)	N/A	N/A	DWS Offset (in)	N/A
N/A	Shared Landing?	N/A			
N/A	Gutter Ponding?	N/A	N/A	Gutter Slope (%)	N/A
N/A	Gutter Lip Ht (in)	N/A	N/A	Gutter X Slope (%)	N/A
N/A	Painted X Walk1?	No	N/A	Painted X Walk2?	No
	X Walk 1 Direction	To N		X Walk 2 Direction	To SW
N/A	X Walk 1 Width (in)	N/A	N/A	X Walk 2 Width (in)	N/A
	X Walk 1 Slope (%)	4.6		X Walk 2 Slope (%)	0.3
	X Walk 1 X Slope (%)	1.6		X Walk 2 X Slope (%)	4.8

N/A	Ramp inside XWalk1?	N/A	N/A	Ramp inside XWalk2?	N/A
	Road Slope (%)	3.6	N/A	Clear Space?	N/A
	Road X Slope (%)	3.7	N/A	Clear Space to XWalk (in)	N/A
N/A	Any Obstructions?	N/A	N/A	Storm Grate/Utility Hazard?	N/A
	Obstruction Type			Storm Grate/Utility Type	
		N/A			N/A
			Yes	Surface Condition? (G/P)	Good

Possible Solutions:

Remove & Replace Curb Ramp With Two New Directional Ramps or Equivalent.
