Access Compliance Report

Public Rights-of-Way

(Curb Ramps)

Intersection ID: 44299	Main Street: PEACH_PLACE_LN	Cross Street: ROCKWOOD_RD	Location: NW
ADA ID: CCAD02F5FCD9	Ramp Type: PerpDiag	Initial Pass/Fail: Fail	Overall Compliance: No
Severity Score: 10			
Codes/Mitigation Info/Possible Solution		Field Measurements/Component Compliance

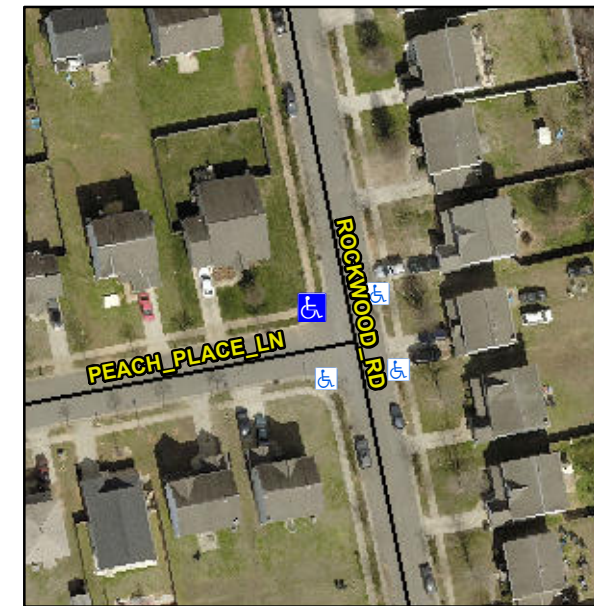
Not Found, R304.5.1, R304.5.3

Compliance	Description	Data	Compliance	Description	Data
N/A	Ramp Length (in)	49.5	Yes	Ramp Slope (%)	7.2
No	Ramp Width (in)	37.5	No	Ramp XSlope (%)	4.1
N/A	Flare Type LT	N/A	N/A	Flare Type RT	N/A
N/A	Flare Slope LT (%)	N/A	N/A	Flare Slope RT (%)	N/A
N/A	Flare Traversable LT?	N/A	N/A	Flare Traversable RT?	N/A
N/A	Landing Length (in)	N/A	N/A	DWS Provided?	N/A
N/A	Landing Width (in)	N/A	N/A	DWS Contrast?	N/A
N/A	Landing Slope (%)	N/A	N/A	DWS Length (in)	N/A
N/A	Landing X Slope (%)	N/A	N/A	DWS Full Width?	N/A
N/A	Landing Curb? (Y/N)	N/A	N/A	DWS Offset (in)	N/A
N/A	Shared Landing?	N/A			
N/A	Gutter Ponding?	N/A	N/A	Gutter Slope (%)	N/A
N/A	Gutter Lip Ht (in)	N/A	N/A	Gutter X Slope (%)	N/A
N/A	Painted X Walk1?	No	N/A	Painted X Walk2?	No
	X Walk 1 Direction	To S		X Walk 2 Direction	To E
N/A	X Walk 1 Width (in)	N/A	N/A	X Walk 2 Width (in)	N/A
	X Walk 1 Slope (%)	3.2		X Walk 2 Slope (%)	1.6
	X Walk 1 X Slope (%)	1.5		X Walk 2 X Slope (%)	3.8

N/A	Ramp inside XWalk1?	N/A	N/A	Ramp inside XWalk2?	N/A
	Road Slope (%)	3.6	N/A	Clear Space?	N/A
	Road X Slope (%)	1.2	N/A	Clear Space to XWalk (in)	N/A
N/A	Any Obstructions?	N/A	N/A	Storm Grate/Utility Hazard?	N/A
	Obstruction Type			Storm Grate/Utility Type	
		N/A			N/A
		Yes		Surface Condition? (G/P)	Good

Remove & Replace Curb Ramp With Two New Directional Ramps or Equivalent.
