# Access Compliance Report

## Public Rights-of-Way

### (Curb Ramps)

Intersection ID: 44477	Main Street: AINSWORTH_ST	Cross Street: WESTHOPE_ST	Location: SE
ADA ID: CCB85179DD8F	Ramp Type: BlendTrans1	Initial Pass/Fail: Fail	Overall Compliance: No
			Severity Score: 18.75

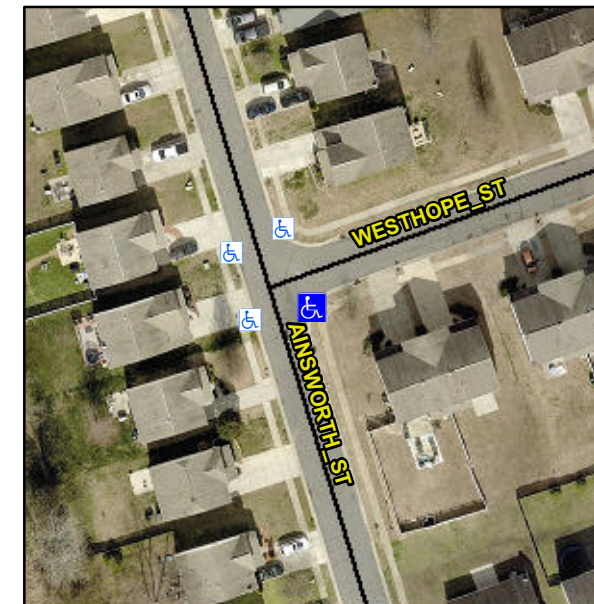
**Not Found, R304.5.1, R304.5.3**

Compliance	Description	Data	Compliance	Description	Data
N/A	Ramp Length (in)	48.0	Yes	BlendTrans Slope (%)	3.4
No	Ramp Width (in)	35.0	No	BlendTrans XSlope (%)	2.9
N/A	Flare Type LT	N/A	N/A	Flare Type RT	N/A
N/A	Flare Slope LT (%)	N/A	N/A	Flare Slope RT (%)	N/A
N/A	Flare Traversable LT?	N/A	N/A	Flare Traversable RT?	N/A
N/A	Landing Length (in)	N/A	N/A	DWS Provided?	N/A
N/A	Landing Width (in)	N/A	N/A	DWS Contrast?	N/A
N/A	Landing Slope (%)	N/A	N/A	DWS Length (in)	N/A
N/A	Landing X Slope (%)	N/A	N/A	DWS Full Width?	N/A
N/A	Landing Curb? (Y/N)	N/A	N/A	DWS Offset (in)	N/A
N/A	Shared Landing?	N/A			
N/A	Gutter Ponding?	N/A	N/A	Gutter Slope (%)	N/A
N/A	Gutter Lip Ht (in)	N/A	N/A	Gutter X Slope (%)	N/A
N/A	Painted X Walk1?	No	N/A	Painted X Walk2?	No
	X Walk 1 Direction	To N		X Walk 2 Direction	To W
	X Walk 1 Width (in)	N/A		X Walk 2 Width (in)	N/A
	X Walk 1 Slope (%)	0.2		X Walk 2 Slope (%)	2.4
	X Walk 1 X Slope (%)	3.6		X Walk 2 X Slope (%)	0.2

N/A	Ramp inside XWalk1?	N/A	N/A	Ramp inside XWalk2?	N/A
	Road Slope (%)	0.5		Clear Space?	N/A
	Road X Slope (%)	0.8	N/A	Clear Space to XWalk (in)	N/A
N/A	Any Obstructions?	N/A	N/A	Storm Grate/Utility Hazard?	N/A
	Obstruction Type			Storm Grate/Utility Type	
		N/A			N/A
			Yes	Surface Condition? (G/P)	Good
			No	Curb Slope (%)	18.2

**Remove & Replace Curb Ramp With Two New Directional Ramps or Equivalent.**
