Access Compliance Report Public Rights-of-Way (Curb Ramps)

Intersection ID: 30220 Main Street: PATRICIA_RYAN_DR			Cross	Cross Street: MARGARET_KELLY_CT				Location:	S
ADA ID: CCB98061E0DI	DA ID: CCB98061E0DD Ramp Type: PerpDiag			nitial Pass/Fail: Fail Overall Compliance: No				o Severity Score:	8.75
Codes/Mitigation Info/Possible Solution				Field Measurements/Component Compliance					
	TRUE SI	Possible Solutions:		Compliance Description			Data Compliance Description		
		Remove & Replace Curb Ramp V	Nith	N/A	Ramp Length (in)	48.0	Yes	Ramp Slope (%)	5.4
		Two New Directional Ramps or		No	Ramp Width (in)	38.0	Yes	Ramp XSlope (%)	1.2
		Equivalent.		N/A	Flare Type LT	N/A	N/A	Flare Type RT	N/A
				N/A	Flare Slope LT (%)	N/A	N/A	Flare Slope RT (%)	N/A
	NGERLAN I			N/A	Flare Traversable LT?	N/A	N/A	Flare Traversable RT?	N/A
Es traise	the seas			N/A	Landing Length (in)	N/A	N/A	DWS Provided?	N/A

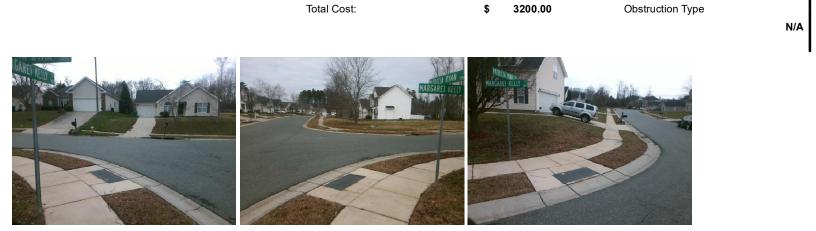
A. 10 1. 10		PROW/ADA:		N/A	Gutter Ponding?	N/A	N/A	Gutter Slope (%)	N/A
	Not Found, R304.5.1		N/A	Gutter Lip Ht (in)	0.5	N/A	Gutter X Slope (%)	N/A	
				N/A	Painted X Walk1?	No	N/A	Painted X Walk2?	No
					X Walk 1 Direction	To N		X Walk 2 Direction	To W
				N/A	X Walk 1 Width (in)	N/A	N/A	X Walk 2 Width (in)	N/A
Street 1 Name	MARGARET KELLY CT	-			X Walk 1 Slope (%)	1.3		X Walk 2 Slope (%)	2.4
Stop Condition-Street 2	StopSign				X Walk 1 X Slope (%)	1.7		X Walk 2 X Slope (%)	0.7
Street 2 Name	PATRICIA RYAN DR			N/A	Ramp inside XWalk1?	N/A	N/A	Ramp inside XWalk2?	N/A
Stop Condition-Street 1	None				Road Slope (%)	0.7	N/A	Clear Space?	N/A
					Road X Slope (%)	1.6	N/A	Clear Space to XWalk (in)	N/A
				N/A	Any Obstructions?	N/A	N/A	Storm Grate/Utility Hazard?	N/A
		Total Cost: \$	3200.00		Obstruction Type			Storm Grate/Utility Type	
						N/A			N/A
