Access Compliance Report

Public Rights-of-Way

(Curb Ramps)

Intersection ID: 14493	Main Street: CARONIA_ST	Cross Street: CLANTON_RD	Location: NW
ADA ID: CCBB46860E03	Ramp Type: Perp	Initial Pass/Fail: Fail	Overall Compliance: No
Severity Score: 13.75			
Codes/Mitigation Info/Possible Solution		Field Measurements/Component Compliance

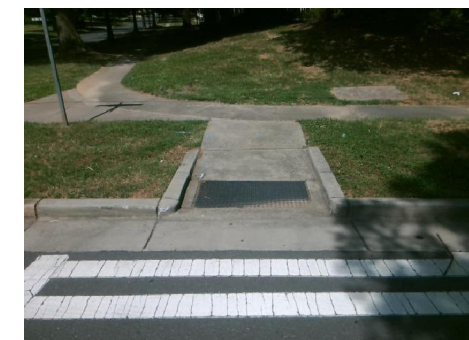
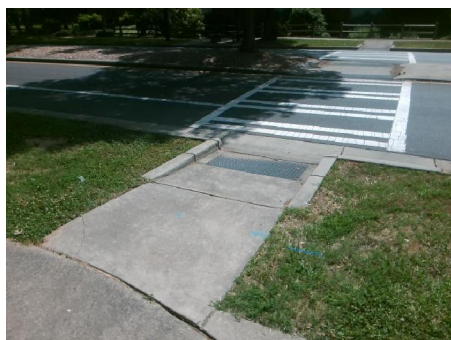
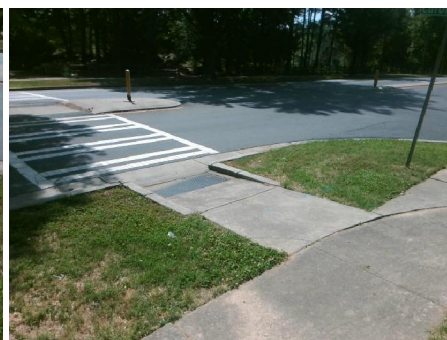
R304.2.2, R304.5.3

Compliance	Description	Data	Compliance	Description	Data
N/A	Ramp Length (in)	60.0	No	Ramp Slope (%)	10.9
Yes	Ramp Width (in)	59.0	No	Ramp XSlope (%)	2.7
N/A	Flare Type LT	N/A	N/A	Flare Type RT	N/A
N/A	Flare Slope LT (%)	N/A	N/A	Flare Slope RT (%)	N/A
N/A	Flare Traversable LT?	N/A	N/A	Flare Traversable RT?	N/A
N/A	Landing Length (in)	N/A	N/A	DWS Provided?	N/A
N/A	Landing Width (in)	N/A	N/A	DWS Contrast?	N/A
N/A	Landing Slope (%)	N/A	N/A	DWS Length (in)	N/A
N/A	Landing X Slope (%)	N/A	N/A	DWS Full Width?	N/A
N/A	Landing Curb? (Y/N)	N/A	N/A	DWS Offset (in)	N/A
N/A	Shared Landing?	N/A			
N/A	Gutter Ponding?	N/A	N/A	Gutter Slope (%)	N/A
N/A	Gutter Lip Ht (in)	N/A	N/A	Gutter X Slope (%)	N/A
N/A	Painted X Walk1?	Yes	N/A	Painted X Walk2?	N/A
	X Walk 1 Direction	To E		X Walk 2 Direction	N/A
N/A	X Walk 1 Width (in)	118.0	N/A	X Walk 2 Width (in)	N/A
	X Walk 1 Slope (%)	4.1		X Walk 2 Slope (%)	N/A
	X Walk 1 X Slope (%)	1.6		X Walk 2 X Slope (%)	N/A

N/A	Ramp inside XWalk1?	Yes	N/A	Ramp inside XWalk2?	N/A
	Road Slope (%)	N/A	N/A	Clear Space?	N/A
	Road X Slope (%)	N/A	N/A	Clear Space to XWalk (in)	N/A
N/A	Any Obstructions?	N/A	N/A	Storm Grate/Utility Hazard?	N/A
	Obstruction Type			Storm Grate/Utility Type	
		N/A			N/A
			Yes	Surface Condition? (G/P)	Good

Remove & Replace Entire Ramp.

Total Cost: \$ 1850.00
