# Access Compliance Report

## Public Rights-of-Way

### (Curb Ramps)

Intersection ID: 20385	Main Street: COOPERSDALE_RD	Cross Street: INGLEHURST_DR	Location: NW
ADA ID: CCC361A5D95F	Ramp Type: Directional1	Initial Pass/Fail: Fail	Overall Compliance: No
Severity Score: 10			
Codes/Mitigation Info/Possible Solution		Field Measurements/Component Compliance

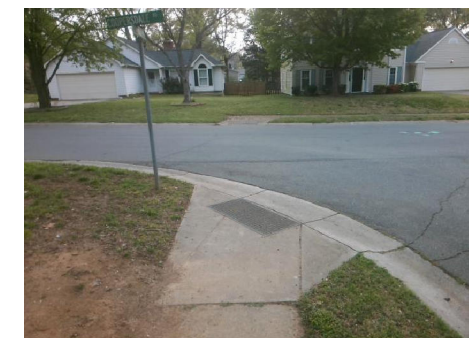
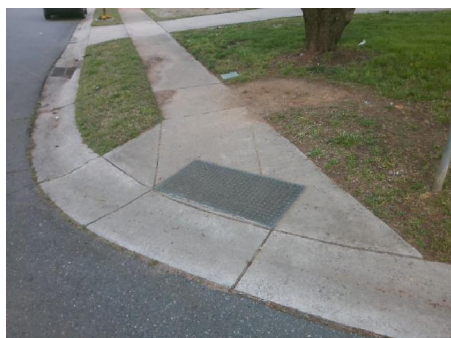
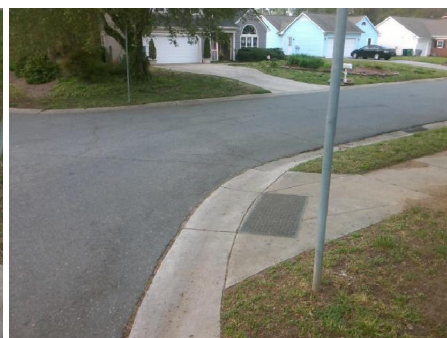
Compliance	Description	Data	Compliance	Description	Data
N/A	Ramp Length (in)	67.0	N/A	Grade Break?	N/A
No	Ramp Width (in)	40.0	N/A	Grade Break Slope (%)	0.0
Yes	Ramp Slope (%)	3.2	N/A	Grade Break XSlope (%)	0.0
No	Ramp XSlope (%)	3.6			
N/A	Flare Type LT	N/A	N/A	Flare Type RT	N/A
N/A	Flare Slope LT (%)	N/A	N/A	Flare Slope RT (%)	0.0
N/A	Flare Traversable LT?	N/A	N/A	Flare Traversable RT?	N/A
N/A	Landing Length (in)	0.0	N/A	DWS Provided?	N/A
N/A	Landing Width (in)	0.0	N/A	DWS Contrast?	N/A
N/A	Landing Slope (%)	0.0	N/A	DWS Length (in)	N/A
N/A	Landing X Slope (%)	0.0	N/A	DWS Full Width?	N/A
N/A	Landing Curb? (Y/N)	N/A	N/A	DWS Offset LT (in)	N/A
N/A	Shared Landing?	N/A	N/A	DWS Offset RT (in)	N/A
N/A	Gutter Ponding?	0.0	N/A	Gutter Slope (%)	N/A
N/A	Gutter Lip Ht (in)	0.0	N/A	Gutter X Slope (%)	N/A
N/A	Painted X Walk1?	No		Road Slope (%)	0.3
	X Walk 1 Direction	To SE		Road X Slope (%)	2.3
	X Walk 1 Width (in)	N/A		Clear Space?	N/A

X Walk 1 Slope (%)	0.3	N/A	Clear Space to XWalk (in)	N/A
	X Walk 1 X Slope (%)	2.3	N/A	Storm Grate/Utility Hazard?	N/A
N/A	Ramp inside XWalk1?	N/A		Storm Grate/Utility Type	
N/A	Any Obstructions?	N/A			N/A
	Obstruction Type		Yes	Surface Condition? (G/P)	Good
			N/A	Curb Slope (%)	3.5

**Remove & Replace Entire Ramp.**
