# Access Compliance Report Public Rights-of-Way (Curb Ramps)

Intersection ID: 7050	Main Street: CARRINGTON_DR	Cross Street: TILDEN_RD	Location: E
ADA ID: CCDCCCD48232	Ramp Type: Perp	Initial Pass/Fail: Fail	Overall Compliance: No Severity Score: 12.5

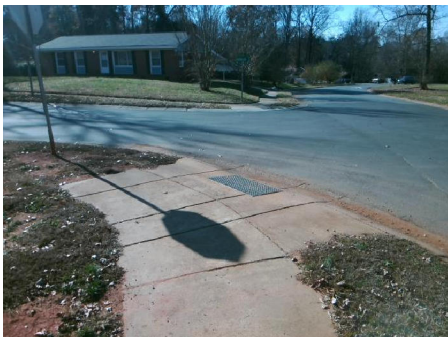
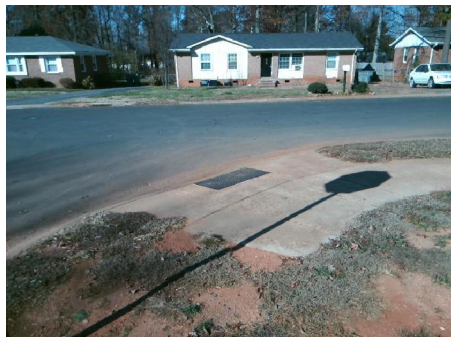
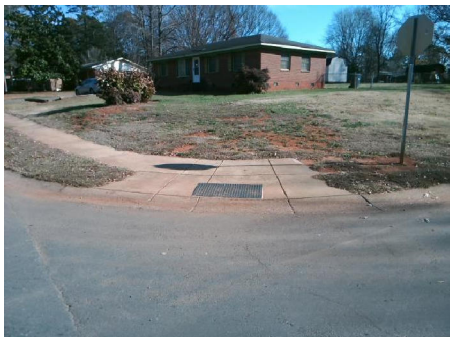
Compliance	Description	Data	Compliance	Description	Data
N/A	Ramp Length (in)	47.0	No	Ramp Slope (%)	11.1
Yes	Ramp Width (in)	49.5	Yes	Ramp XSlope (%)	1.3
N/A	Flare Type LT	N/A	N/A	Flare Type RT	N/A
N/A	Flare Slope LT (%)	N/A	N/A	Flare Slope RT (%)	N/A
N/A	Flare Traversable LT?	N/A	N/A	Flare Traversable RT?	N/A
N/A	Landing Length (in)	N/A	N/A	DWS Provided?	N/A
N/A	Landing Width (in)	N/A	N/A	DWS Contrast?	N/A
N/A	Landing Slope (%)	N/A	N/A	DWS Length (in)	N/A
N/A	Landing X Slope (%)	N/A	N/A	DWS Full Width?	N/A
N/A	Landing Curb? (Y/N)	N/A	N/A	DWS Offset (in)	N/A
N/A	Shared Landing?	N/A			
N/A	Gutter Ponding?	Yes	N/A	Gutter Slope (%)	N/A
N/A	Gutter Lip Ht (in)	N/A	N/A	Gutter X Slope (%)	N/A
N/A	Painted X Walk1?	No	N/A	Painted X Walk2?	N/A
	X Walk 1 Direction	To W		X Walk 2 Direction	N/A
N/A	X Walk 1 Width (in)	N/A	N/A	X Walk 2 Width (in)	N/A
	X Walk 1 Slope (%)	0.5		X Walk 2 Slope (%)	N/A
	X Walk 1 X Slope (%)	2.1		X Walk 2 X Slope (%)	N/A

N/A	Ramp inside XWalk1?	N/A	N/A	Ramp inside XWalk2?	N/A
	Road Slope (%)	N/A	N/A	Clear Space?	N/A
	Road X Slope (%)	N/A	N/A	Clear Space to XWalk (in)	N/A
N/A	Any Obstructions?	N/A	N/A	Storm Grate/Utility Hazard?	N/A
	Obstruction Type			Storm Grate/Utility Type	
			N/A		N/A
			Yes	Surface Condition? (G/P)	Good

**Remove & Replace Entire Ramp.**

**R304.2.2**
