# Access Compliance Report

## Public Rights-of-Way (Curb Ramps)

Intersection ID: N/A	Main Street: PERIWINKLE_HILL_CT	Cross Street: N/A	Location: W
ADA ID: CCDFB8D68C81	Ramp Type: Perp	Initial Pass/Fail: Pass	Overall Compliance: No
Severity Score: 0			
Codes/Mitigation Info/Possible Solution		Field Measurements/Component Compliance

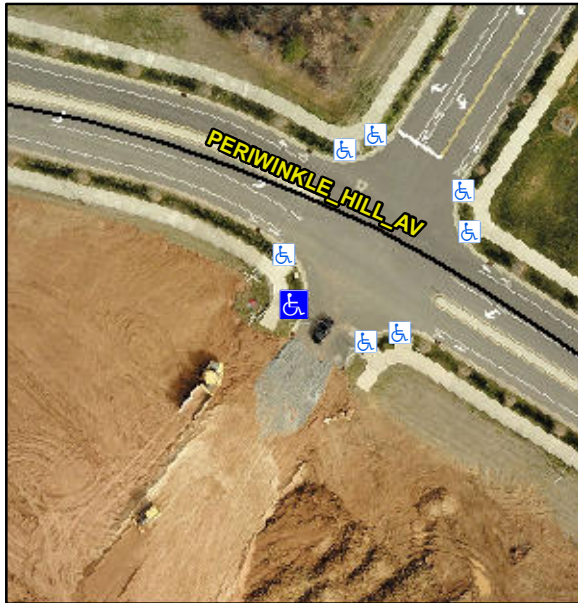
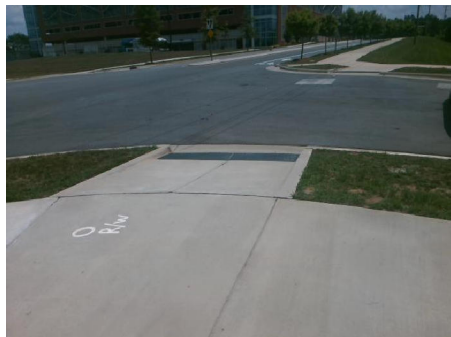
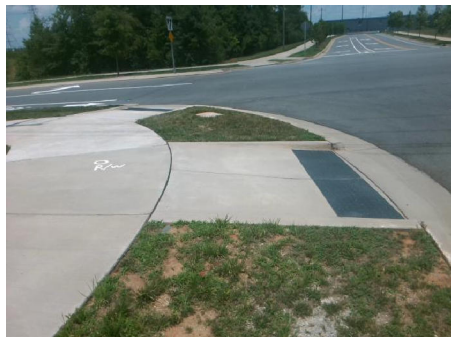
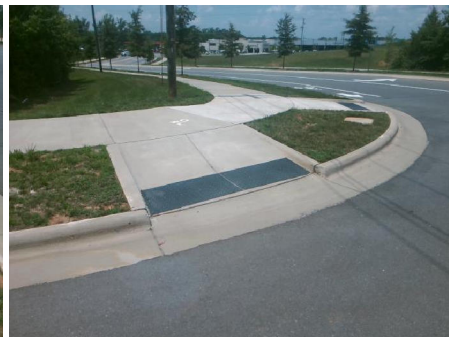
**Not Found, R305.2**

Compliance	Description	Data	Compliance	Description	Data
N/A	Ramp Length (in)	99.0	Yes	Ramp Slope (%)	8.0
Yes	Ramp Width (in)	91.0	Yes	Ramp XSlope (%)	0.3
Yes	Flare Type L	Curbed_NoWalkSurface	Yes	Flare Type RT	N/A
Yes	Flare Slope LT (%)	N/A	N/A	Flare Slope RT (%)	N/A
N/A	Flare Traversable LT?	No	N/A	Flare Traversable RT?	No
Yes	Landing Length (in)	96.0	Yes	DWS Provided?	Yes
Yes	Landing Width (in)	64.0	Yes	DWS Contrast?	Yes
Yes	Landing Slope (%)	1.6	Yes	DWS Length (in)	24.0
Yes	Landing X Slope (%)	1.0	Yes	DWS Full Width?	Yes
N/A	Landing Curb? (Y/N)	No	No	DWS Offset (in)	3.0
N/A	Shared Landing?	No			
Yes	Gutter Ponding?	No	Yes	Gutter Slope (%)	0.6
Yes	Gutter Lip Ht (in)	0.0	Yes	Gutter X Slope (%)	0.7
N/A	Painted X Walk1?	No	N/A	Painted X Walk2?	N/A
	X Walk 1 Direction	To SE		X Walk 2 Direction	N/A
N/A	X Walk 1 Width (in)	N/A	N/A	X Walk 2 Width (in)	N/A
	X Walk 1 Slope (%)	7.0		X Walk 2 Slope (%)	N/A
	X Walk 1 X Slope (%)	3.4		X Walk 2 X Slope (%)	N/A

N/A	Ramp inside XWalk1?	N/A	N/A	Ramp inside XWalk2?	N/A
	Road Slope (%)	N/A	N/A	Clear Space?	Yes
	Road X Slope (%)	N/A	N/A	Clear Space to XWalk (in)	N/A
Yes	Any Obstructions?	No	Yes	Storm Grate/Utility Hazard?	No
	Obstruction Type			Storm Grate/Utility Type	
		N/A			N/A
			Yes	Surface Condition? (G/P)	Good

**Remove & Replace Entire Ramp.**

Total Cost: \$ 1850.00
