Good

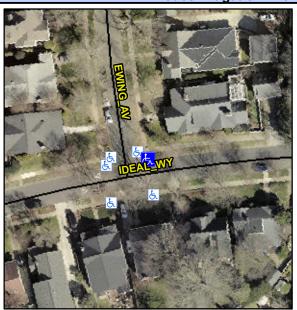
Possible Solutions:	
Remove & Replace Entire Ramp. Remove & Replace Gutter.	
Surveyor Notes: N/A	
PROW/ADA: Not Found, R304.5.3, R305, R302.7.2

Street 1 Name	IDEAL WY
Stop Condition-Street 2	None
Street 2 Name	N/A
Stop Condition-Street 1	N/A
