# Access Compliance Report

## Public Rights-of-Way

### (Curb Ramps)

Intersection ID: 50735	Main Street: JONES RIDGE DR	Cross Street: OLD PROVIDENCE RD	Location: W
ADA ID: CCEEDC18F356	Ramp Type: PerpDiag	Initial Pass/Fail: Fail	Overall Compliance: No
Severity Score: 13.75			
Codes/Mitigation Info/Possible Solution		Field Measurements/Component Compliance

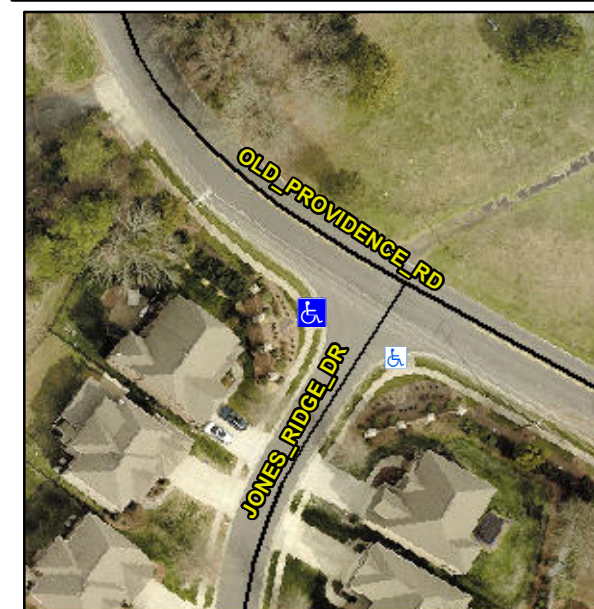
**Not Found, R304.2.2, R304.5.3**

Compliance	Description	Data	Compliance	Description	Data
N/A	Ramp Length (in)	53.5	No	Ramp Slope (%)	11.0
Yes	Ramp Width (in)	48.0	No	Ramp XSlope (%)	3.3
N/A	Flare Type LT	N/A	N/A	Flare Type RT	N/A
N/A	Flare Slope LT (%)	N/A	N/A	Flare Slope RT (%)	N/A
N/A	Flare Traversable LT?	N/A	N/A	Flare Traversable RT?	N/A
N/A	Landing Length (in)	N/A	N/A	DWS Provided?	N/A
N/A	Landing Width (in)	N/A	N/A	DWS Contrast?	N/A
N/A	Landing Slope (%)	N/A	N/A	DWS Length (in)	N/A
N/A	Landing X Slope (%)	N/A	N/A	DWS Full Width?	N/A
N/A	Landing Curb? (Y/N)	N/A	N/A	DWS Offset (in)	N/A
N/A	Shared Landing?	N/A			
N/A	Gutter Ponding?	N/A	N/A	Gutter Slope (%)	N/A
N/A	Gutter Lip Ht (in)	N/A	N/A	Gutter X Slope (%)	N/A
N/A	Painted X Walk1?	No	N/A	Painted X Walk2?	No
	X Walk 1 Direction	To SE		X Walk 2 Direction	To NE
N/A	X Walk 1 Width (in)	N/A	N/A	X Walk 2 Width (in)	N/A
	X Walk 1 Slope (%)	2.5		X Walk 2 Slope (%)	1.5
	X Walk 1 X Slope (%)	1.9		X Walk 2 X Slope (%)	3.0

N/A	Ramp inside XWalk1?	N/A	N/A	Ramp inside XWalk2?	N/A
	Road Slope (%)	3.0	N/A	Clear Space?	N/A
	Road X Slope (%)	1.3	N/A	Clear Space to XWalk (in)	N/A
N/A	Any Obstructions?	N/A	N/A	Storm Grate/Utility Hazard?	N/A
	Obstruction Type			Storm Grate/Utility Type	
		N/A			N/A
			Yes	Surface Condition? (G/P)	Good

**Remove & Replace Curb Ramp With Two New Directional Ramps or Equivalent.**
