# Access Compliance Report

## Public Rights-of-Way

### (Curb Ramps)

| Intersection ID: 16848 | Main Street: MONTAGUE_ST | Cross Street: DALLAS_AV | Location: SE |

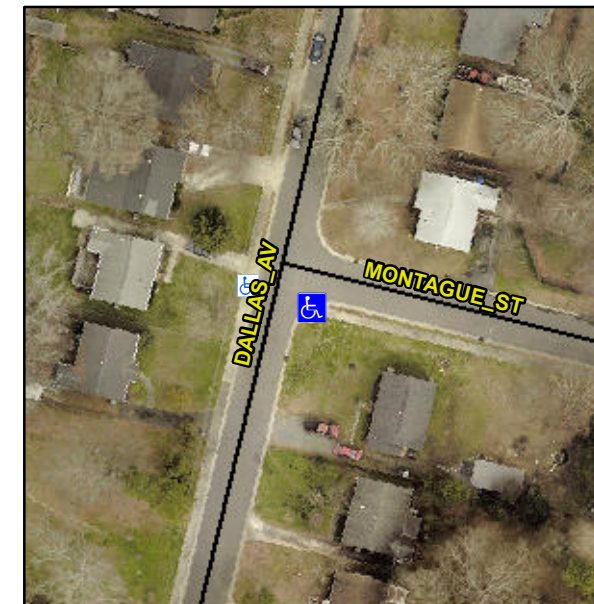
| ADA ID: CCF0306ADD9F | Ramp Type: PerpDiag | Initial Pass/Fail: Fail | Overall Compliance: No |
| | | Severity Score: 22.5 | |

**Not Found, R304.5.1, R304.2.2, R304.5.3**

| Compliance | Description | Data | Compliance | Description | Data |
|---|---|---|---|---|---|
| N/A | Ramp Length (in) | 23.0 | No | Ramp Slope (%) | 11.2 |
| No | Ramp Width (in) | 43.5 | No | Ramp XSlope (%) | 2.3 |

**Remove & Replace Curb Ramp With Two New Directional Ramps or Equivalent.**

Total Cost: \$ 3200.00
