Access Compliance Report

Public Rights-of-Way

(Curb Ramps)

| Intersection ID: 54775 | Main Street: N_SHARON_AMITY_RD | Cross Street: INDEPENDENCE/I-277_RA | Location: N |

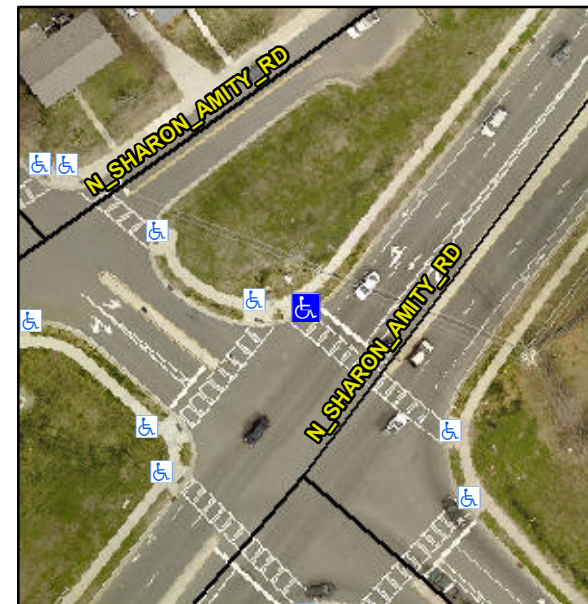
| ADA ID: CCF85FA8A2B8 | Ramp Type: Perp | Initial Pass/Fail: Fail | Overall Compliance: No |
| | | | Severity Score: 12.5 |

Not Found, R304.2.2

| Compliance | Description | Data | Compliance | Description | Data |
|---|---|---|---|---|---|
| N/A | Ramp Length (in) | 64.0 | No | Ramp Slope (%) | 9.4 |

Remove & Replace Entire Ramp.
