# Access Compliance Report

## Public Rights-of-Way

### (Curb Ramps)

Intersection ID: 51011	Main Street: TREMONT_PLACE_RD	Cross Street: BENDING_BRANCH_RD	Location: W
ADA ID: CCFA2A922E9B	Ramp Type: Perp	Initial Pass/Fail: Fail	Overall Compliance: No
Severity Score: 22.5			
Codes/Mitigation Info/Possible Solution		Field Measurements/Component Compliance

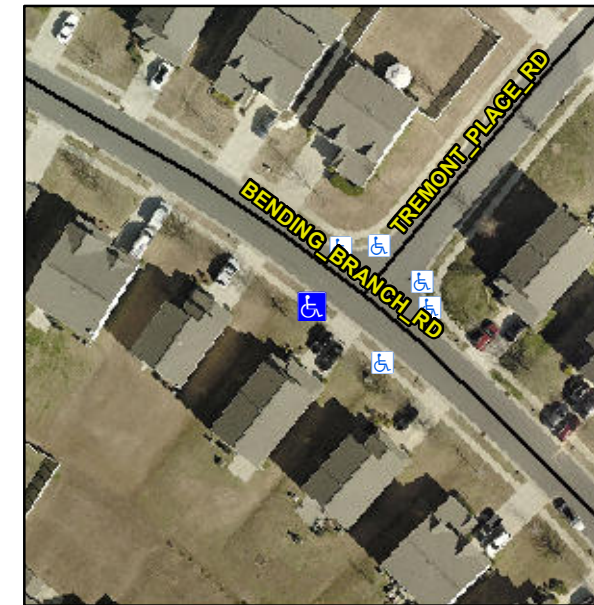
**Not Found, R304.5.1, R304.2.2, R304.5.3**

Compliance	Description	Data	Compliance	Description	Data
N/A	Ramp Length (in)	48.0	No	Ramp Slope (%)	9.5
No	Ramp Width (in)	47.5	No	Ramp XSlope (%)	3.1
N/A	Flare Type LT	N/A	N/A	Flare Type RT	N/A
N/A	Flare Slope LT (%)	N/A	N/A	Flare Slope RT (%)	N/A
N/A	Flare Traversable LT?	N/A	N/A	Flare Traversable RT?	N/A
N/A	Landing Length (in)	N/A	N/A	DWS Provided?	N/A
N/A	Landing Width (in)	N/A	N/A	DWS Contrast?	N/A
N/A	Landing Slope (%)	N/A	N/A	DWS Length (in)	N/A
N/A	Landing X Slope (%)	N/A	N/A	DWS Full Width?	N/A
N/A	Landing Curb? (Y/N)	N/A	N/A	DWS Offset (in)	N/A
N/A	Shared Landing?	N/A			
N/A	Gutter Ponding?	N/A	N/A	Gutter Slope (%)	N/A
N/A	Gutter Lip Ht (in)	N/A	N/A	Gutter X Slope (%)	N/A
N/A	Painted X Walk1?	No	N/A	Painted X Walk2?	N/A
	X Walk 1 Direction	To NE		X Walk 2 Direction	N/A
N/A	X Walk 1 Width (in)	N/A	N/A	X Walk 2 Width (in)	N/A
	X Walk 1 Slope (%)	1.5		X Walk 2 Slope (%)	N/A
	X Walk 1 X Slope (%)	2.8		X Walk 2 X Slope (%)	N/A

N/A	Ramp inside XWalk1?	N/A	N/A	Ramp inside XWalk2?	N/A
	Road Slope (%)	N/A	N/A	Clear Space?	N/A
	Road X Slope (%)	N/A	N/A	Clear Space to XWalk (in)	N/A
N/A	Any Obstructions?	N/A	N/A	Storm Grate/Utility Hazard?	N/A
	Obstruction Type			Storm Grate/Utility Type	
		N/A			N/A
			Yes	Surface Condition? (G/P)	Good

**Remove & Replace Entire Ramp.**
