## Access Compliance Report Public Rights-of-Way (Curb Ramps)

Intersection ID: 48785 Main Street: PARK\_SHARON\_CT Cross Street: PARK\_RD Location: SW

ADA ID: CD22C0EA3212 Ramp Type: PerpDiag Initial Pass/Fail: Fail Overall Compliance: No Severity Score: 22.5

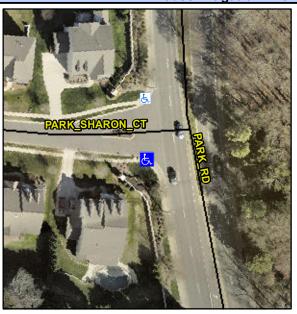
Not Found, R304.5.1, R304.2.2, R304.5.3

| Compliance Description D | | Data | Compliance Description | | Data |
|---|---|---|---|---|---|
| N/A | Ramp Length (in) | 59.0 | No | Ramp Slope (%) | 9.0 |
| No | Ramp Width (in) | 46.0 | No | Ramp XSlope (%) | 4.8 |

Remove & Replace Curb Ramp With Two New Directional Ramps or Equivalent.
