Access Compliance Report

Public Rights-of-Way

(Curb Ramps)

Intersection ID: 27772	Main Street: BRIARWICK_LN	Cross Street: NORTH_COMMUNITY_HOUSE_RD	Location: SE
ADA ID: CD251376959F	Ramp Type: Perp	Initial Pass/Fail: Fail	Overall Compliance: No
		Severity Score: 42.5

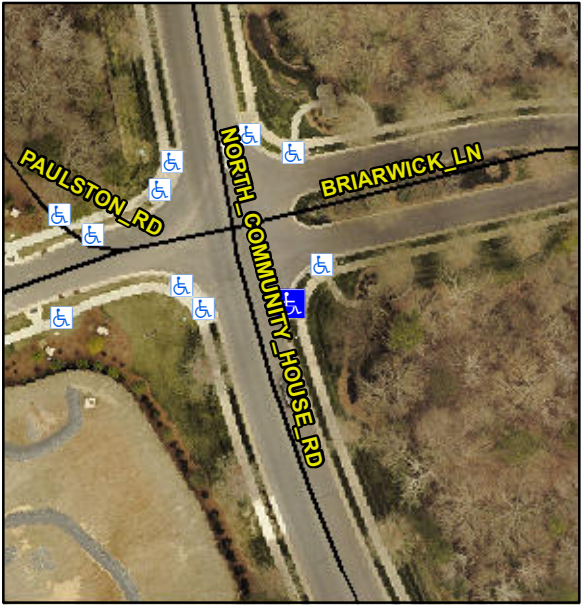
Possible Solutions:		Compliance	Description	Data
	Remove & Replace Entire Ramp.		No	Ramp Length (in)	108.0
			No	Ramp Width (in)	35.0
			N/A	Flare Type LT	N/A
			N/A	Flare Slope LT (%)	N/A
			N/A	Flare Traversable LT?	N/A
			N/A	Landing Length (in)	N/A
			N/A	Landing Width (in)	N/A
			N/A	Landing Slope (%)	N/A
			N/A	Landing X Slope (%)	N/A
<p>Surveyor Notes:</p> <p>N/A</p> <p>PROW/ADA:</p> <p>R304.5.1, R304.2.2, R304.5.3</p>			N/A	Flare Type RT	N/A
			N/A	Flare Slope RT (%)	N/A
			N/A	Flare Traversable RT?	N/A
			N/A	DWS Provided?	N/A
			N/A	DWS Contrast?	N/A
			N/A	DWS Length (in)	N/A
			N/A	DWS Full Width?	N/A
			N/A	DWS Offset (in)	N/A
			N/A	Gutter Ponding?	N/A
			N/A	Gutter Lip Ht (in)	N/A
<p>Total Cost:</p> <p>\$ 1850.00</p>			No	Painted X Walk1?	N/A
			To W	X Walk 2 Direction	N/A
			N/A	X Walk 2 Width (in)	N/A

10.6	X Walk 2 Slope (%)	N/A
			1.5	X Walk 2 X Slope (%)	N/A
			N/A	Ramp inside XWalk1?	N/A
			N/A	Ramp inside XWalk2?	N/A
			N/A	Clear Space?	N/A
			N/A	Clear Space to XWalk (in)	N/A
			N/A	Storm Grate/Utility Hazard?	N/A
			N/A	Storm Grate/Utility Type	N/A
			N/A	Surface Condition? (G/P)	Good
