Access Compliance Report

Public Rights-of-Way

(Curb Ramps)

Intersection ID: 28345	Main Street: BACARDI_CT	Cross Street: HIRSCH_DR	Location: SE
ADA ID: CD2A5B354039	Ramp Type: Perp	Initial Pass/Fail: Fail	Overall Compliance: No
		Severity Score: 8.75

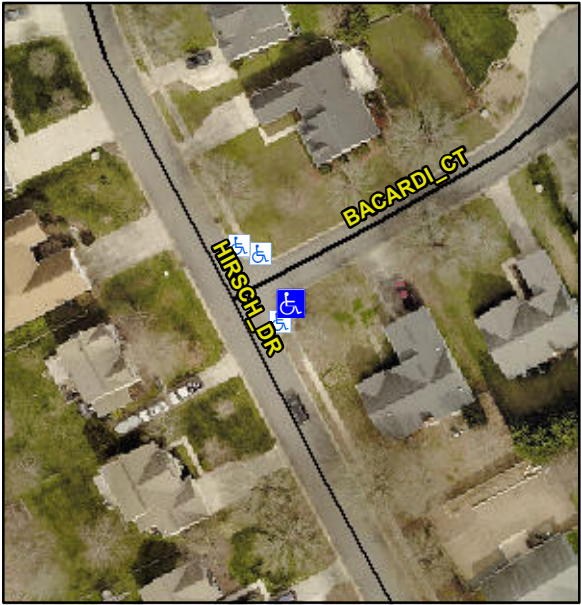
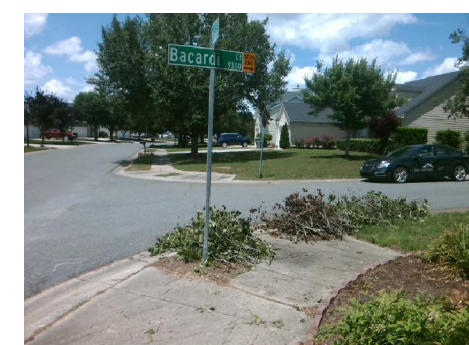
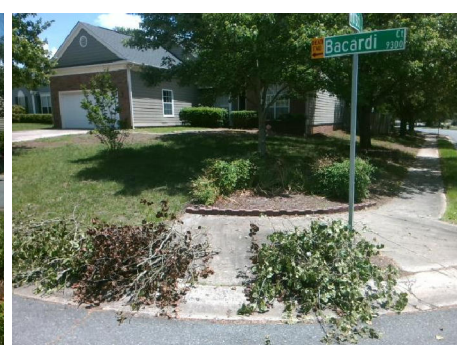
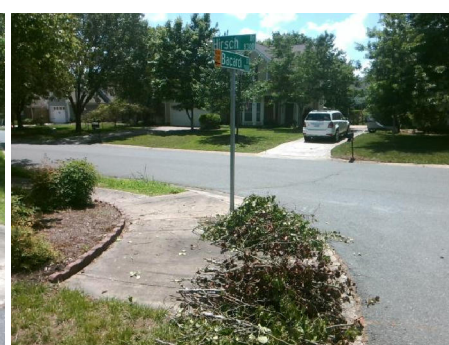
Possible Solutions:		Compliance	Description	Data
	Remove & Replace Entire Ramp.		Yes	Ramp Length (in)	93.0
			No	Ramp Width (in)	47.0
			N/A	Flare Type LT	N/A
			N/A	Flare Slope LT (%)	N/A
			N/A	Flare Traversable LT?	N/A
			N/A	Landing Length (in)	N/A
			N/A	Landing Width (in)	N/A
			N/A	Landing Slope (%)	N/A
			N/A	Landing X Slope (%)	N/A
<p>Surveyor Notes:</p> <p>N/A</p> <p>PROW/ADA:</p> <p>Not Found, R304.5.1</p>			N/A	Landing Curb? (Y/N)	N/A
			N/A	Shared Landing?	N/A
			N/A	Gutter Ponding?	N/A
			N/A	Gutter Lip Ht (in)	N/A
			N/A	Painted X Walk1?	No
				X Walk 1 Direction	To NW
			N/A	X Walk 1 Width (in)	N/A
				X Walk 1 Slope (%)	2.0
				X Walk 1 X Slope (%)	3.0
			N/A	Ramp inside XWalk1?	N/A
<p>Street 1 Name</p> <p>Stop Condition-Street 2</p> <p>Street 2 Name</p> <p>Stop Condition-Street 1</p>			N/A	Road Slope (%)	N/A

N/A	Road X Slope (%)	N/A
			N/A	Any Obstructions?	N/A
				Obstruction Type	
			N/A		
			N/A		
			N/A		
			N/A		
			N/A		
			N/A		
<p>Total Cost:</p> <p>\$ 1850.00</p>			N/A	Clear Space?	N/A
			N/A	Clear Space to XWalk (in)	N/A
			N/A	Storm Grate/Utility Hazard?	N/A
				Storm Grate/Utility Type	
			N/A		
			N/A		
			N/A		
			N/A		
			N/A		
			N/A		
<p>Street 1 Name</p> <p>Stop Condition-Street 2</p> <p>Street 2 Name</p> <p>Stop Condition-Street 1</p>			Yes	Surface Condition? (G/P)	Good
