# Access Compliance Report

## Public Rights-of-Way

Intersection ID: 14135	Main Street: CHESTERFIELD_AV	Cross Street: HANOVER_ST	Location: E
ADA ID: CD2E72996F87	Ramp Type: PerpDiag	Initial Pass/Fail: Fail	Overall Compliance: No
		Severity Score: 22.5

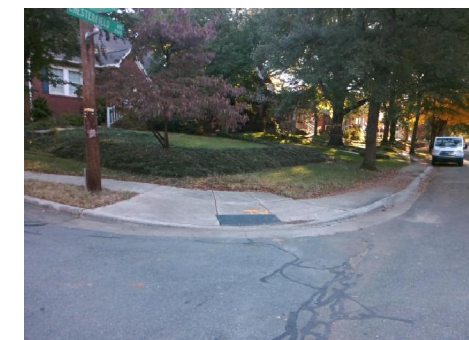
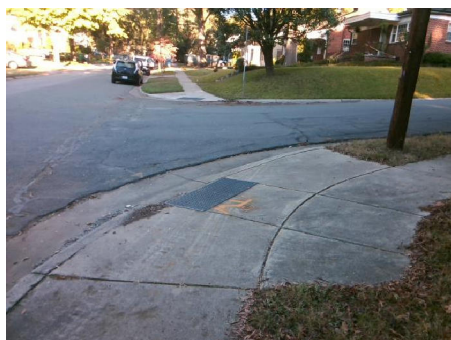
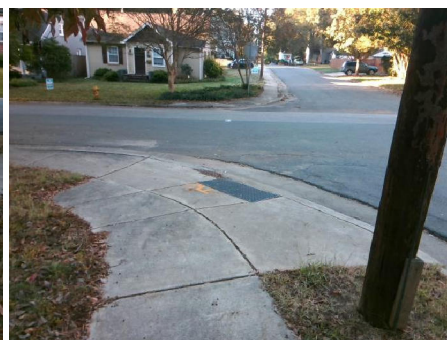
**Not Found, R304.5.1, R304.2.2, R304.5.3**

Compliance	Description	Data	Compliance	Description	Data
N/A	Ramp Length (in)	59.5	No	Ramp Slope (%)	9.0
No	Ramp Width (in)	41.0	No	Ramp XSlope (%)	4.3
N/A	Flare Type LT	N/A	N/A	Flare Type RT	N/A
N/A	Flare Slope LT (%)	N/A	N/A	Flare Slope RT (%)	N/A
N/A	Flare Traversable LT?	N/A	N/A	Flare Traversable RT?	N/A
N/A	Landing Length (in)	N/A	N/A	DWS Provided?	N/A
N/A	Landing Width (in)	N/A	N/A	DWS Contrast?	N/A
N/A	Landing Slope (%)	N/A	N/A	DWS Length (in)	N/A
N/A	Landing X Slope (%)	N/A	N/A	DWS Full Width?	N/A
N/A	Landing Curb? (Y/N)	N/A	N/A	DWS Offset (in)	N/A
N/A	Shared Landing?	N/A			
N/A	Gutter Ponding?	Yes	N/A	Gutter Slope (%)	N/A
N/A	Gutter Lip Ht (in)	1.5	N/A	Gutter X Slope (%)	N/A
N/A	Painted X Walk1?	No	N/A	Painted X Walk2?	No
	X Walk 1 Direction	To NW		X Walk 2 Direction	To SW
N/A	X Walk 1 Width (in)	N/A	N/A	X Walk 2 Width (in)	N/A
	X Walk 1 Slope (%)	6.0		X Walk 2 Slope (%)	0.4
	X Walk 1 X Slope (%)	3.1		X Walk 2 X Slope (%)	3.0

N/A	Ramp inside XWalk1?	N/A	N/A	Ramp inside XWalk2?	N/A
	Road Slope (%)	4.2	N/A	Clear Space?	N/A
	Road X Slope (%)	0.1	N/A	Clear Space to XWalk (in)	N/A
N/A	Any Obstructions?	N/A	N/A	Storm Grate/Utility Hazard?	N/A
	Obstruction Type			Storm Grate/Utility Type	
		N/A			N/A
		Yes		Surface Condition? (G/P)	Good

**Remove & Replace Curb Ramp With Two New Directional Ramps or Equivalent.**
