Access Compliance Report

Public Rights-of-Way

(Curb Ramps)

| Intersection ID: 31839 | Main Street: RUGGED_STONE_WY | Cross Street: SILVER_FALLS_WY | Location: SW |

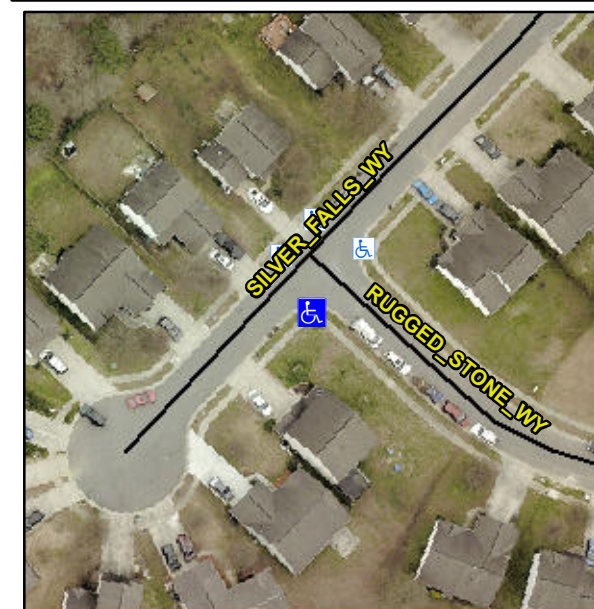
Not Found, R304.5.1, R304.2.2, R304.5.3

| Compliance | Description | Data | Compliance | Description | Data |
|---|---|---|---|---|---|
| N/A | Ramp Length (in) | 47.0 | No | Ramp Slope (%) | 11.4 |
| No | Ramp Width (in) | 45.0 | No | Ramp XSlope (%) | 6.8 |

Remove & Replace Curb Ramp With Two New Directional Ramps or Equivalent.
