# Access Compliance Report

## Public Rights-of-Way

### (Curb Ramps)

Intersection ID: 15017	Main Street: BALTIMORE_AV	Cross Street: GRIFFITH_ST	Location: S
ADA ID: CD38865616CA	Ramp Type: PerpDiag	Initial Pass/Fail: Fail	Overall Compliance: No
Severity Score: 10			
Codes/Mitigation Info/Possible Solution		Field Measurements/Component Compliance

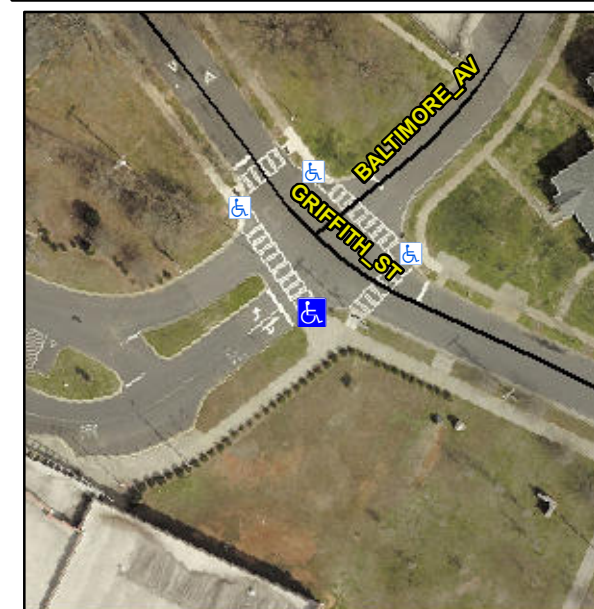
**Not Found, R304.5.1, R304.5.3**

Compliance	Description	Data	Compliance	Description	Data
N/A	Ramp Length (in)	180.0	Yes	Ramp Slope (%)	6.2
No	Ramp Width (in)	47.0	No	Ramp XSlope (%)	2.1
N/A	Flare Type LT	N/A	N/A	Flare Type RT	N/A
N/A	Flare Slope LT (%)	N/A	N/A	Flare Slope RT (%)	N/A
N/A	Flare Traversable LT?	N/A	N/A	Flare Traversable RT?	N/A
N/A	Landing Length (in)	N/A	N/A	DWS Provided?	N/A
N/A	Landing Width (in)	N/A	N/A	DWS Contrast?	N/A
N/A	Landing Slope (%)	N/A	N/A	DWS Length (in)	N/A
N/A	Landing X Slope (%)	N/A	N/A	DWS Full Width?	N/A
N/A	Landing Curb? (Y/N)	N/A	N/A	DWS Offset (in)	N/A
N/A	Shared Landing?	N/A			
N/A	Gutter Ponding?	N/A	N/A	Gutter Slope (%)	N/A
N/A	Gutter Lip Ht (in)	N/A	N/A	Gutter X Slope (%)	N/A
N/A	Painted X Walk1?	No	N/A	Painted X Walk2?	Yes
	X Walk 1 Direction	To NE		X Walk 2 Direction	To NW
N/A	X Walk 1 Width (in)	N/A	N/A	X Walk 2 Width (in)	116.0
	X Walk 1 Slope (%)	1.4		X Walk 2 Slope (%)	0.7
	X Walk 1 X Slope (%)	3.5		X Walk 2 X Slope (%)	0.9

N/A	Ramp inside XWalk1?	N/A	N/A	Ramp inside XWalk2?	Yes
	Road Slope (%)	2.1	N/A	Clear Space?	N/A
	Road X Slope (%)	0.9	N/A	Clear Space to XWalk (in)	N/A
N/A	Any Obstructions?	N/A	N/A	Storm Grate/Utility Hazard?	N/A
	Obstruction Type			Storm Grate/Utility Type	
		N/A			N/A
			Yes	Surface Condition? (G/P)	Good

**Remove & Replace Curb Ramp With Two New Directional Ramps or Equivalent.**
