Access Compliance Report

Public Rights-of-Way

(Curb Ramps)

Intersection ID: 10022634	Main Street: CARMEL_RD	Cross Street: N/A	Location: SE
ADA ID: CD3AC2CBFBF5	Ramp Type: PerpDiag	Initial Pass/Fail: Fail	Overall Compliance: No
Severity Score: 12.5			
Codes/Mitigation Info/Possible Solution		Field Measurements/Component Compliance

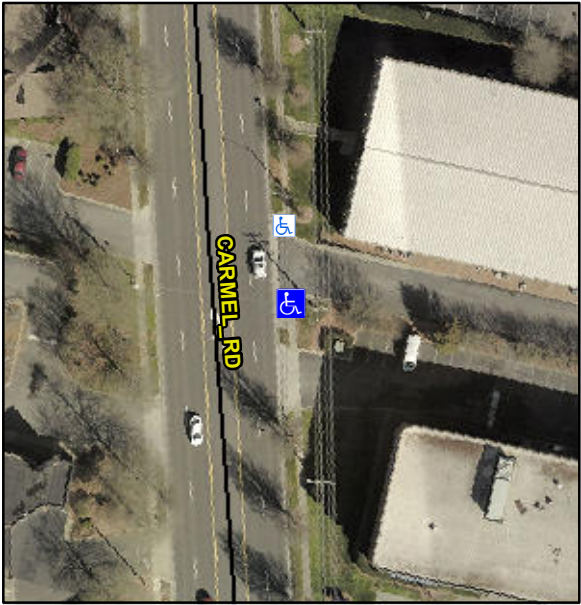
Possible Solutions:	Compliance	Description	Data	Compliance	Description	Data
	Remove & Replace Curb Ramp With Two New Directional Ramps or Equivalent.	N/A	Ramp Length (in)	86.0	Yes	Ramp Slope (%)	7.0
		Yes	Ramp Width (in)	48.0	No	Ramp XSlope (%)	6.0
		N/A	Flare Type LT	N/A	N/A	Flare Type RT	N/A
		N/A	Flare Slope LT (%)	N/A	N/A	Flare Slope RT (%)	N/A
		N/A	Flare Traversable LT?	N/A	N/A	Flare Traversable RT?	N/A
		N/A	Landing Length (in)	N/A	N/A	DWS Provided?	N/A
		N/A	Landing Width (in)	N/A	N/A	DWS Contrast?	N/A
		N/A	Landing Slope (%)	N/A	N/A	DWS Length (in)	N/A
		N/A	Landing X Slope (%)	N/A	N/A	DWS Full Width?	N/A
<p>Surveyor Notes:</p> <p>N/A</p> <p>PROW/ADA:</p> <p>Not Found, R304.5.3</p>		N/A	Landing Curb? (Y/N)	N/A	N/A	DWS Offset (in)	N/A
		N/A	Shared Landing?	N/A			
		N/A	Gutter Ponding?	N/A	N/A	Gutter Slope (%)	N/A
		N/A	Gutter Lip Ht (in)	N/A	N/A	Gutter X Slope (%)	N/A
		N/A	Painted X Walk1?	No	N/A	Painted X Walk2?	No

X Walk 1 Direction	To N		X Walk 2 Direction	To W
		N/A	X Walk 1 Width (in)	N/A	N/A	X Walk 2 Width (in)	N/A
			X Walk 1 Slope (%)	0.0		X Walk 2 Slope (%)	0.7
			X Walk 1 X Slope (%)	6.6		X Walk 2 X Slope (%)	1.0
		N/A	Ramp inside XWalk1?	N/A	N/A	Ramp inside XWalk2?	N/A
<p>Street 1 Name</p> <p>Stop Condition-Street 2</p> <p>Street 2 Name</p> <p>Stop Condition-Street 1</p>	ENTRANCE <p>None</p> <p>CARMEL RD</p> <p>None</p>		Road Slope (%)	3.6	N/A	Clear Space?	N/A
			Road X Slope (%)	5.3	N/A	Clear Space to XWalk (in)	N/A
		N/A	Any Obstructions?	N/A	N/A	Storm Grate/Utility Hazard?	N/A
			Obstruction Type			Storm Grate/Utility Type	
					N/A		N/A
					Yes	Surface Condition? (G/P)	Good
Total Cost:		\$	3200.00
