# Access Compliance Report Public Rights-of-Way (Curb Ramps)

| Intersection ID: 10247 | Main Street: BURTON_ST | Cross Street: WHISNANT_ST | Location: NE |
| ADA ID: CD44BAAFDD82 | Ramp Type: Combination2 | Initial Pass/Fail: Fail | Overall Compliance: No<br>Severity Score: 36.25 |

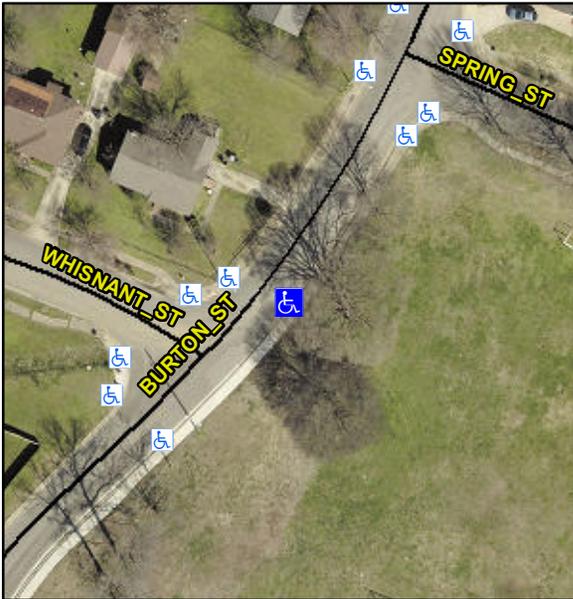
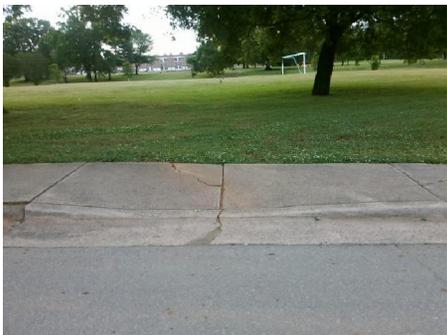
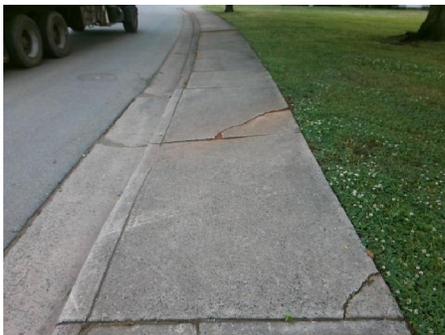
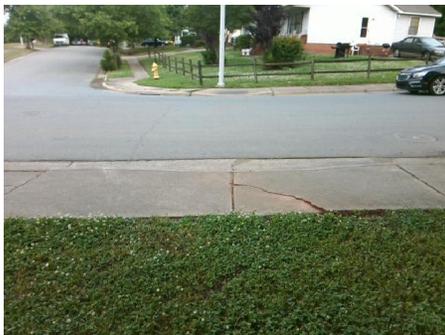
**RT RP < 5%**

**Not Found, R304.5.1, R304.5.1, R304.5.3**

| Compliance | Description | Data | Compliance | Description | Data |
|---|---|---|---|---|---|
| No | Ramp Width LT (in) | 37.0 | N/A | Ramp Width RT (in) | 30.0 |
| No | Ramp XSlope LT (%) | 5.0 | N/A | Ramp XSlope RT (%) | 2.3 |
| No | Ramp Width (in) | 40.0 | Yes | Ramp XSlope (%) | 2.9 |

**Remove & Replace Entire Ramp.**
