Access Compliance Report

Public Rights-of-Way

(Curb Ramps)

Intersection ID: 27495	Main Street: BALLANTYNE_COMMONS_PY	Cross Street: NORTH_COMMUNITY_HOUSE_RD	Location: NE
ADA ID: CD55F7E2A3E8	Ramp Type: Perp	Initial Pass/Fail: Fail	Overall Compliance: No
Severity Score: 21.25			
Codes/Mitigation Info/Possible Solution		Field Measurements/Component Compliance

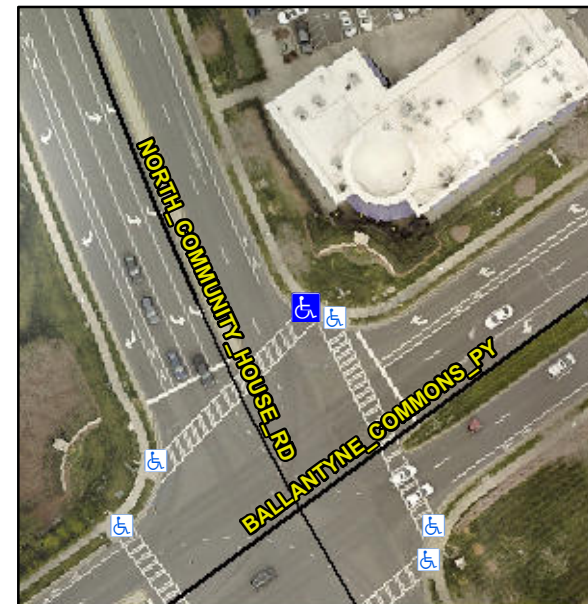
R304.5.1, R304.2.2

Compliance	Description	Data	Compliance	Description	Data
N/A	Ramp Length (in)	47.5	No	Ramp Slope (%)	8.5
No	Ramp Width (in)	46.5	Yes	Ramp XSlope (%)	1.8
N/A	Flare Type LT	N/A	N/A	Flare Type RT	N/A
N/A	Flare Slope LT (%)	N/A	N/A	Flare Slope RT (%)	N/A
N/A	Flare Traversable LT?	N/A	N/A	Flare Traversable RT?	N/A
N/A	Landing Length (in)	N/A	N/A	DWS Provided?	N/A
N/A	Landing Width (in)	N/A	N/A	DWS Contrast?	N/A
N/A	Landing Slope (%)	N/A	N/A	DWS Length (in)	N/A
N/A	Landing X Slope (%)	N/A	N/A	DWS Full Width?	N/A
N/A	Landing Curb? (Y/N)	N/A	N/A	DWS Offset (in)	N/A
N/A	Shared Landing?	N/A			
N/A	Gutter Ponding?	N/A	N/A	Gutter Slope (%)	N/A
N/A	Gutter Lip Ht (in)	N/A	N/A	Gutter X Slope (%)	N/A
N/A	Painted X Walk1?	Yes	N/A	Painted X Walk2?	N/A
	X Walk 1 Direction	To SW		X Walk 2 Direction	N/A
N/A	X Walk 1 Width (in)	125.5	N/A	X Walk 2 Width (in)	N/A
	X Walk 1 Slope (%)	4.4		X Walk 2 Slope (%)	N/A
	X Walk 1 X Slope (%)	0.9		X Walk 2 X Slope (%)	N/A

N/A	Ramp inside XWalk1?	Yes	N/A	Ramp inside XWalk2?	N/A
	Road Slope (%)	N/A	N/A	Clear Space?	N/A
	Road X Slope (%)	N/A	N/A	Clear Space to XWalk (in)	N/A
N/A	Any Obstructions?	N/A	N/A	Storm Grate/Utility Hazard?	N/A
	Obstruction Type			Storm Grate/Utility Type	
		N/A			N/A
		Yes		Surface Condition? (G/P)	Good

Possible Solutions:

Remove & Replace Entire Ramp.
