Access Compliance Report

Public Rights-of-Way

(Curb Ramps)

Intersection ID: 10019902	Main Street: ARCO_CORPORATE_DR	Cross Street: N/A	Location: SW
ADA ID: CD6300E81B27	Ramp Type: PerpDiag	Initial Pass/Fail: Fail	Overall Compliance: No
		Severity Score: 22.5

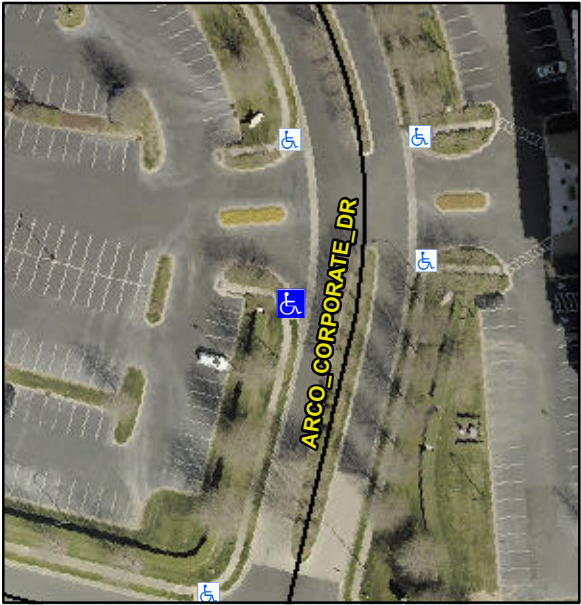
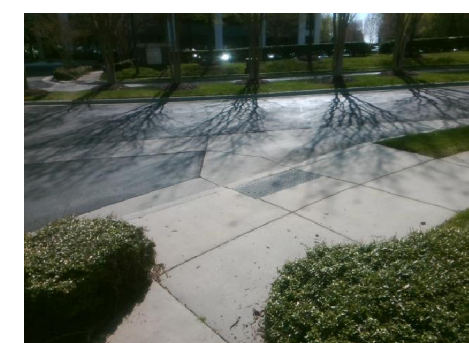
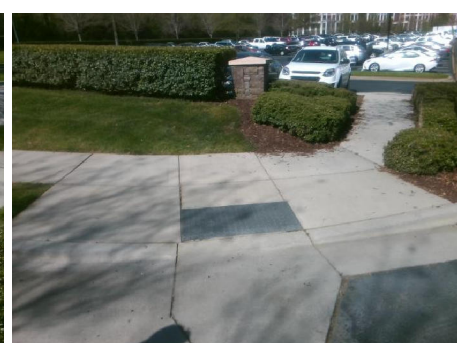
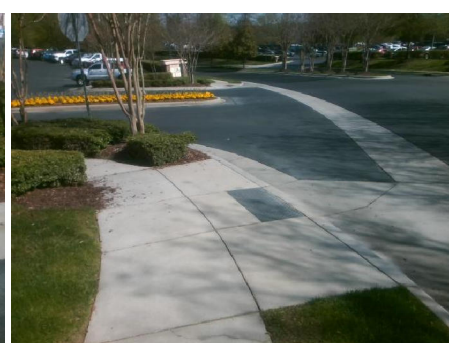
Possible Solutions:		Compliance	Description	Data
	Remove & Replace Curb Ramp With Two New Directional Ramps or Equivalent.		No	Ramp Length (in)	48.0
			No	Ramp Width (in)	46.0
			N/A	Flare Type LT	N/A
			N/A	Flare Slope LT (%)	N/A
			N/A	Flare Traversable LT?	N/A
			N/A	Landing Length (in)	N/A
			N/A	Landing Width (in)	N/A
			N/A	Landing Slope (%)	N/A
			N/A	Landing X Slope (%)	N/A
<p>Surveyor Notes:</p> <p>N/A</p> <p>PROW/ADA:</p> <p>Not Found, R304.5.1, R304.2.2, R304.5.3</p>			N/A	Flare Type RT	N/A
			N/A	Flare Slope RT (%)	N/A
			N/A	Flare Traversable RT?	N/A
			N/A	DWS Provided?	N/A
			N/A	DWS Contrast?	N/A
			N/A	DWS Length (in)	N/A
			N/A	DWS Full Width?	N/A
			N/A	DWS Offset (in)	N/A
			N/A	Gutter Ponding?	N/A
			N/A	Gutter Lip Ht (in)	N/A
<p>Total Cost:</p> <p>\$ 3200.00</p>			No	Painted X Walk1?	No
			To E	X Walk 2 Direction	To N

N/A	X Walk 2 Width (in)	N/A
			1.9	X Walk 2 Slope (%)	4.1
			3.8	X Walk 2 X Slope (%)	1.5
			N/A	Ramp inside XWalk2?	N/A
			2.5	Clear Space?	N/A
			1.8	Clear Space to XWalk (in)	N/A
			N/A	Storm Grate/Utility Hazard?	N/A
			N/A	Storm Grate/Utility Type	N/A
			N/A	Surface Condition? (G/P)	Good
