Access Compliance Report

Public Rights-of-Way

(Curb Ramps)

Intersection ID: 16818	Main Street: MONROE_RD	Cross Street: GLENDORA DR	Location: NE
ADA ID: CD6F2294D263	Ramp Type: PerpDiag	Initial Pass/Fail: Fail	Overall Compliance: No
		Severity Score: 42.5

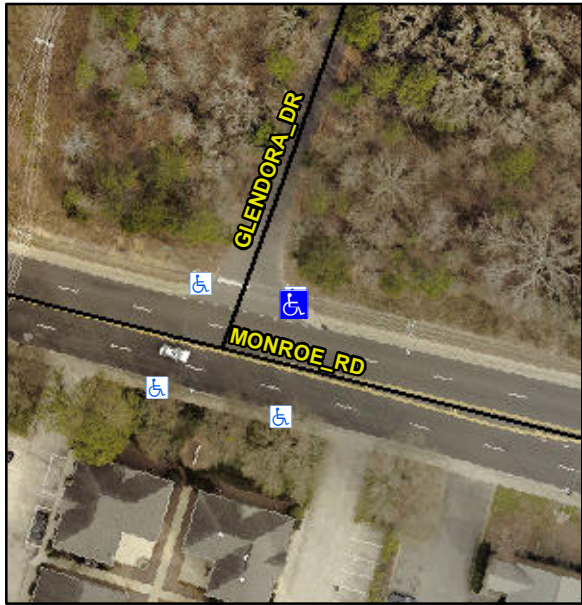
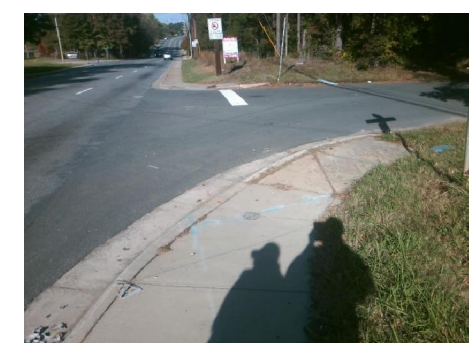
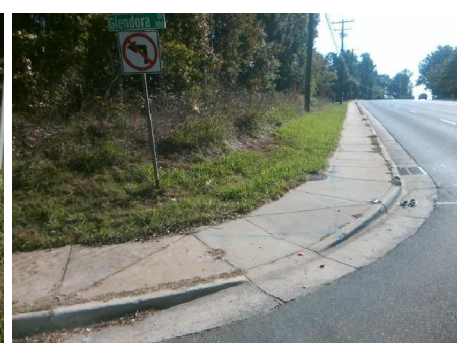
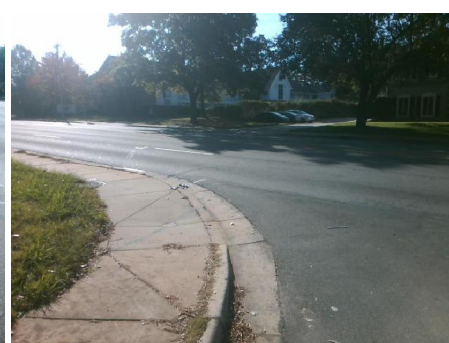
Codes/Mitigation Info/Possible Solution			Field Measurements/Component Compliance

Possible Solutions:		Compliance	Description	Data	Compliance	Description	Data
	Remove & Replace Curb Ramp With Two New Directional Ramps or Equivalent.		N/A	Ramp Length (in)	59.0	No	Ramp Slope (%)	10.9
			No	Ramp Width (in)	35.0	No	Ramp XSlope (%)	6.6
			N/A	Flare Type LT	N/A	N/A	Flare Type RT	N/A
			N/A	Flare Slope LT (%)	N/A	N/A	Flare Slope RT (%)	N/A
			N/A	Flare Traversable LT?	N/A	N/A	Flare Traversable RT?	N/A
			N/A	Landing Length (in)	N/A	N/A	DWS Provided?	N/A
			N/A	Landing Width (in)	N/A	N/A	DWS Contrast?	N/A
			N/A	Landing Slope (%)	N/A	N/A	DWS Length (in)	N/A
			N/A	Landing X Slope (%)	N/A	N/A	DWS Full Width?	N/A
Surveyor Notes:		N/A	N/A	Landing Curb? (Y/N)	N/A	N/A	DWS Offset (in)	N/A
PROW/ADA:		Not Found, R304.5.1, R304.2.2, R304.5.3	N/A	Shared Landing?	N/A	N/A	Gutter Slope (%)	N/A
			N/A	Gutter Ponding?	N/A	N/A	Gutter X Slope (%)	N/A

N/A	Gutter Lip Ht (in)	N/A	N/A	Painted X Walk2?	No
			N/A	Painted X Walk1?	No	N/A	X Walk 2 Direction	To SW
			N/A	X Walk 1 Direction	To NW	N/A	X Walk 2 Width (in)	N/A
			N/A	X Walk 1 Width (in)	N/A	N/A	X Walk 2 Slope (%)	6.1
				X Walk 1 Slope (%)	1.8		X Walk 2 X Slope (%)	2.5
				X Walk 1 X Slope (%)	4.3		Ramp inside XWalk2?	N/A
			N/A	Ramp inside XWalk1?	N/A	N/A	Clear Space?	N/A
				Road Slope (%)	4.6	N/A	Clear Space to XWalk (in)	N/A
				Road X Slope (%)	3.7	N/A	Storm Grate/Utility Hazard?	N/A
			N/A	Any Obstructions?	N/A	N/A	Storm Grate/Utility Type	
				Obstruction Type		N/A		N/A
						Yes	Surface Condition? (G/P)	Good
Total Cost:		\$ 3200.00						
Street 1 Name		GLENDORA DR						
Stop Condition-Street 2		StopSign						
Street 2 Name		MONROE RD						
Stop Condition-Street 1		None
