Intersection ID: 12384	Main Street: FRIAR_ST	Cross Street: PRUITT_ST	Location:	SE
ADA ID: CD6F26A27814	Ramp Type: Perp	Initial Pass/Fail: Fail	Overall Compliance: No	Severity Score: 25

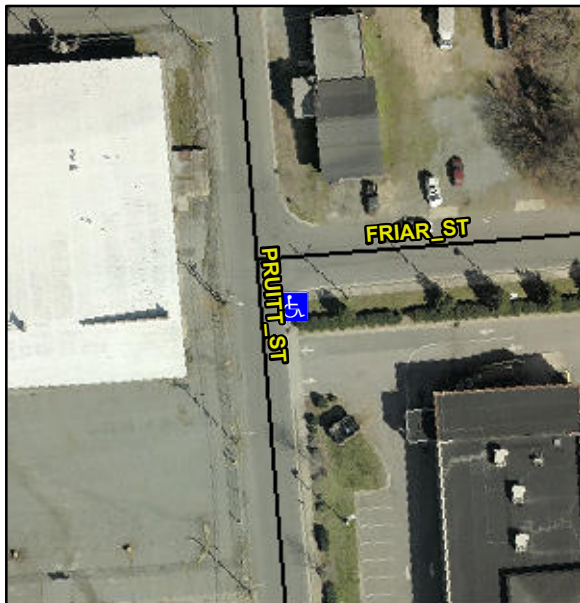
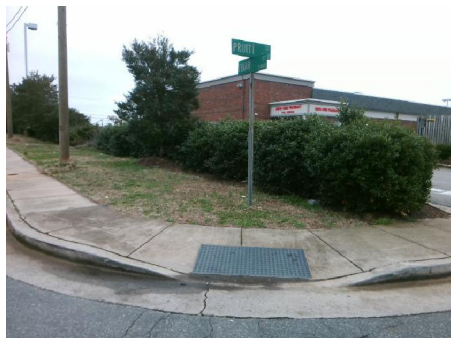
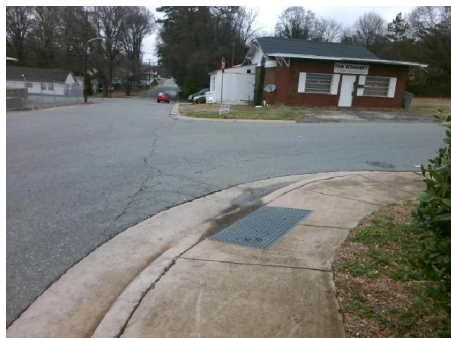
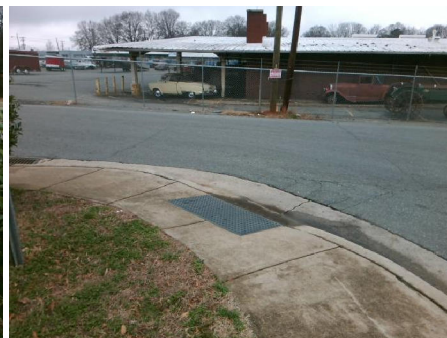
Possible Solutions:		Compliance			Description			Data			
	Remove & Replace Entire Ramp.		N/A	Ramp Length (in)		50.0		No	Ramp Slope (%)		15.3	
			Yes	Ramp Width (in)		50.0		Yes	Ramp XSlope (%)		0.8	
			N/A	Flare Type LT		N/A		N/A	Flare Type RT		N/A	
			N/A	Flare Slope LT (%)		N/A		N/A	Flare Slope RT (%)		N/A	
			N/A	Flare Traversable LT?		N/A		N/A	Flare Traversable RT?		N/A	
			N/A	Landing Length (in)		N/A		N/A	DWS Provided?		N/A	
			N/A	Landing Width (in)		N/A		N/A	DWS Contrast?		N/A	
			N/A	Landing Slope (%)		N/A		N/A	DWS Length (in)		N/A	
			N/A	Landing X Slope (%)		N/A		N/A	DWS Full Width?		N/A	
Surveyor Notes:			N/A	Landing Curb? (Y/N)		N/A		N/A	DWS Offset (in)		N/A	
N/A			N/A	Shared Landing?		N/A						
PROW/ADA:			N/A	Gutter Ponding?		N/A		N/A	Gutter Slope (%)		N/A	
Not Found, R304.2.2			N/A	Gutter Lip Ht (in)		N/A		N/A	Gutter X Slope (%)		N/A

N/A	Painted X Walk1?		No		N/A	Painted X Walk2?		N/A	
				X Walk 1 Direction		To N			X Walk 2 Direction		N/A	
			N/A	X Walk 1 Width (in)		N/A		N/A	X Walk 2 Width (in)		N/A	
				X Walk 1 Slope (%)		0.8			X Walk 2 Slope (%)		N/A	
				X Walk 1 X Slope (%)		5.0			X Walk 2 X Slope (%)		N/A	
Street 1 Name		FRIAR ST	N/A	Ramp inside XWalk1?		N/A		N/A	Ramp inside XWalk2?		N/A	
Stop Condition-Street 2		StopSign		Road Slope (%)		4.0		N/A	Clear Space?		N/A	
Street 2 Name		N/A		Road X Slope (%)		0.1		N/A	Clear Space to XWalk (in)		N/A	
Stop Condition-Street 1		N/A		N/A	N/A		N/A	Storm Grate/Utility Hazard?		N/A		
Total Cost:			\$	1850.00					Storm Grate/Utility Type			
						N/A					N/A	
								Yes	Surface Condition? (G/P)		Good
