# Access Compliance Report

## Public Rights-of-Way

### (Curb Ramps)

Intersection ID: 10029503	Main Street: KENSINGTON PALACE LN	Cross Street: N/A	Location: S
ADA ID: CD721A6E9E55	Ramp Type: Perp	Initial Pass/Fail: Fail	Overall Compliance: No
Severity Score: 48.75			
Codes/Mitigation Info/Possible Solution		Field Measurements/Component Compliance

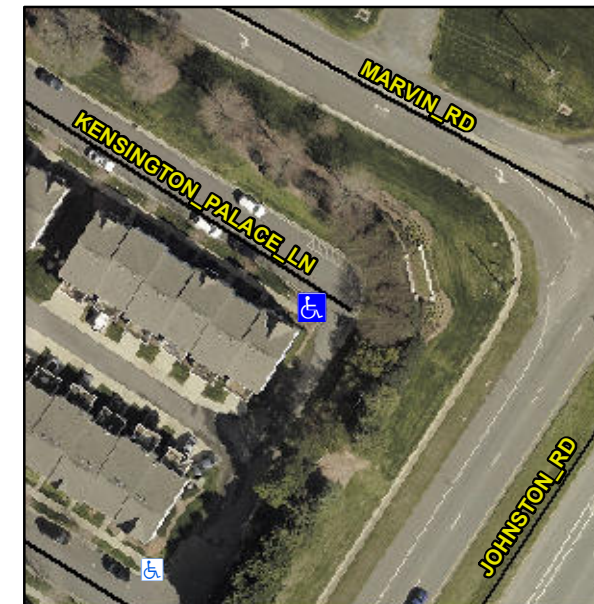
**R304.5.1, R304.2.2, R304.5.3**

Compliance	Description	Data	Compliance	Description	Data
N/A	Ramp Length (in)	48.0	No	Ramp Slope (%)	10.8
No	Ramp Width (in)	25.0	No	Ramp XSlope (%)	4.4
N/A	Flare Type LT	N/A	N/A	Flare Type RT	N/A
N/A	Flare Slope LT (%)	N/A	N/A	Flare Slope RT (%)	N/A
N/A	Flare Traversable LT?	N/A	N/A	Flare Traversable RT?	N/A
N/A	Landing Length (in)	N/A	N/A	DWS Provided?	N/A
N/A	Landing Width (in)	N/A	N/A	DWS Contrast?	N/A
N/A	Landing Slope (%)	N/A	N/A	DWS Length (in)	N/A
N/A	Landing X Slope (%)	N/A	N/A	DWS Full Width?	N/A
N/A	Landing Curb? (Y/N)	N/A	N/A	DWS Offset (in)	N/A
N/A	Shared Landing?	N/A			
N/A	Gutter Ponding?	N/A	N/A	Gutter Slope (%)	N/A
N/A	Gutter Lip Ht (in)	N/A	N/A	Gutter X Slope (%)	N/A
N/A	Painted X Walk1?	No	N/A	Painted X Walk2?	N/A
	X Walk 1 Direction	To NE		X Walk 2 Direction	N/A
N/A	X Walk 1 Width (in)	N/A	N/A	X Walk 2 Width (in)	N/A
	X Walk 1 Slope (%)	1.3		X Walk 2 Slope (%)	N/A
	X Walk 1 X Slope (%)	3.8		X Walk 2 X Slope (%)	N/A

N/A	Ramp inside XWalk1?	N/A	N/A	Ramp inside XWalk2?	N/A
	Road Slope (%)	N/A	N/A	Clear Space?	N/A
	Road X Slope (%)	N/A	N/A	Clear Space to XWalk (in)	N/A
N/A	Any Obstructions?	N/A	N/A	Storm Grate/Utility Hazard?	N/A
	Obstruction Type			Storm Grate/Utility Type	
		N/A			N/A
			Yes	Surface Condition? (G/P)	Good

Possible Solutions:

**Remove & Replace Entire Ramp.**

Total Cost: \$ 1850.00
