Access Compliance Report

Public Rights-of-Way

(Curb Ramps)

Intersection ID: 17505	Main Street: CRAIG_AV	Cross Street: N_SHARON_AMITY_RD	Location: N
ADA ID: CD7F32D9CF23	Ramp Type: PerpDiag	Initial Pass/Fail: Fail	Overall Compliance: No
		Severity Score: 22.5

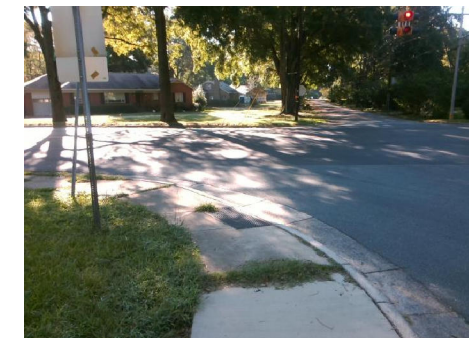
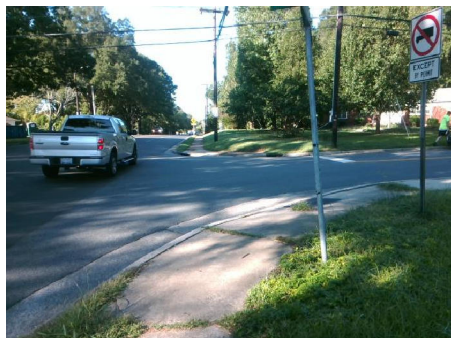
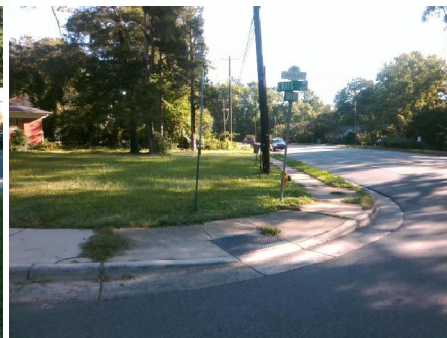
Not Found, R304.5.1, R304.2.2, R304.5.3

Compliance	Description	Data	Compliance	Description	Data
N/A	Ramp Length (in)	59.0	No	Ramp Slope (%)	11.5
No	Ramp Width (in)	39.0	No	Ramp XSlope (%)	4.6
N/A	Flare Type LT	N/A	N/A	Flare Type RT	N/A
N/A	Flare Slope LT (%)	N/A	N/A	Flare Slope RT (%)	N/A
N/A	Flare Traversable LT?	N/A	N/A	Flare Traversable RT?	N/A
N/A	Landing Length (in)	N/A	N/A	DWS Provided?	N/A
N/A	Landing Width (in)	N/A	N/A	DWS Contrast?	N/A
N/A	Landing Slope (%)	N/A	N/A	DWS Length (in)	N/A
N/A	Landing X Slope (%)	N/A	N/A	DWS Full Width?	N/A
N/A	Landing Curb? (Y/N)	N/A	N/A	DWS Offset (in)	N/A
N/A	Shared Landing?	N/A			
N/A	Gutter Ponding?	N/A	N/A	Gutter Slope (%)	N/A
N/A	Gutter Lip Ht (in)	N/A	N/A	Gutter X Slope (%)	N/A
N/A	Painted X Walk1?	No	N/A	Painted X Walk2?	No
	X Walk 1 Direction	To SW		X Walk 2 Direction	To SE
N/A	X Walk 1 Width (in)	N/A	N/A	X Walk 2 Width (in)	N/A
	X Walk 1 Slope (%)	3.4		X Walk 2 Slope (%)	1.4
	X Walk 1 X Slope (%)	2.4		X Walk 2 X Slope (%)	3.2

N/A	Ramp inside XWalk1?	N/A	N/A	Ramp inside XWalk2?	N/A
	Road Slope (%)	4.4	N/A	Clear Space?	N/A
	Road X Slope (%)	1.7	N/A	Clear Space to XWalk (in)	N/A
N/A	Any Obstructions?	N/A	N/A	Storm Grate/Utility Hazard?	N/A
	Obstruction Type			Storm Grate/Utility Type	
		N/A			N/A
			Yes	Surface Condition? (G/P)	Good

Remove & Replace Curb Ramp With Two New Directional Ramps or Equivalent.
