Access Compliance Report

Public Rights-of-Way

(Curb Ramps)

Intersection ID: 9073	Main Street: HUNTERS_CROSSING_LN	Cross Street: THE_PLAZA	Location:	N
ADA ID: CD80335862FD	Ramp Type: PerpDiag	Initial Pass/Fail: Fail	Overall Compliance: No	Severity Score: 8.75
Codes/Mitigation Info/Possible Solution		Field Measurements/Component Compliance

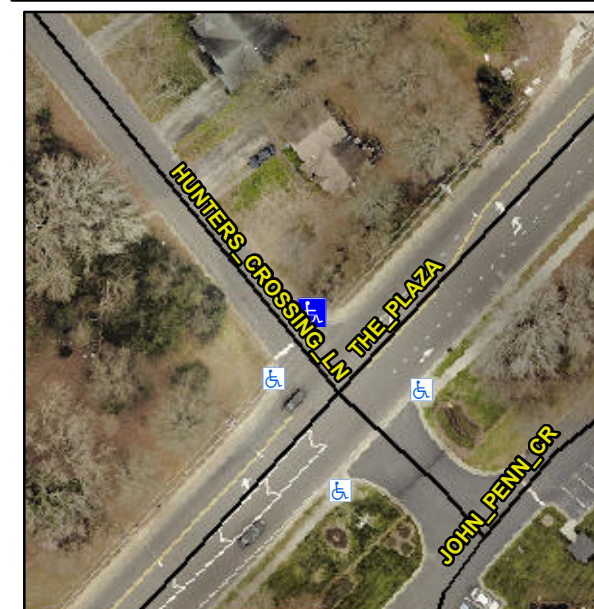
Not Found, R304.5.1

Compliance	Description	Data	Compliance	Description	Data
N/A	Ramp Length (in)	61.5	Yes	Ramp Slope (%)	6.5
No	Ramp Width (in)	46.0	Yes	Ramp XSlope (%)	1.4
N/A	Flare Type LT	N/A	N/A	Flare Type RT	N/A
N/A	Flare Slope LT (%)	N/A	N/A	Flare Slope RT (%)	N/A
N/A	Flare Traversable LT?	N/A	N/A	Flare Traversable RT?	N/A
N/A	Landing Length (in)	N/A	N/A	DWS Provided?	N/A
N/A	Landing Width (in)	N/A	N/A	DWS Contrast?	N/A
N/A	Landing Slope (%)	N/A	N/A	DWS Length (in)	N/A
N/A	Landing X Slope (%)	N/A	N/A	DWS Full Width?	N/A
N/A	Landing Curb? (Y/N)	N/A	N/A	DWS Offset (in)	N/A
N/A	Shared Landing?	N/A			
N/A	Gutter Ponding?	Yes	N/A	Gutter Slope (%)	N/A
N/A	Gutter Lip Ht (in)	N/A	N/A	Gutter X Slope (%)	N/A
N/A	Painted X Walk1?	No	N/A	Painted X Walk2?	No
	X Walk 1 Direction	To SW		X Walk 2 Direction	To SE
N/A	X Walk 1 Width (in)	N/A	N/A	X Walk 2 Width (in)	N/A
	X Walk 1 Slope (%)	0.8		X Walk 2 Slope (%)	2.2
	X Walk 1 X Slope (%)	0.4		X Walk 2 X Slope (%)	2.5

N/A	Ramp inside XWalk1?	N/A	N/A	Ramp inside XWalk2?	N/A
	Road Slope (%)	0.3	N/A	Clear Space?	N/A
	Road X Slope (%)	1.2	N/A	Clear Space to XWalk (in)	N/A
N/A	Any Obstructions?	N/A	N/A	Storm Grate/Utility Hazard?	N/A
	Obstruction Type			Storm Grate/Utility Type	
		N/A			N/A
		Yes		Surface Condition? (G/P)	Good

Remove & Replace Curb Ramp With Two New Directional Ramps or Equivalent.

Total Cost: \$ 3200.00
