Access Compliance Report

Public Rights-of-Way (Curb Ramps)

Intersection ID: 44232	Main Street: PAPER_BIRCH_DR	Cross Street: MAIDENHAIR_CT	Location: NW
ADA ID: CD83D4B6D5E8	Ramp Type: Perp	Initial Pass/Fail: Fail	Overall Compliance: No
Severity Score: 12.5			
Codes/Mitigation Info/Possible Solution		Field Measurements/Component Compliance

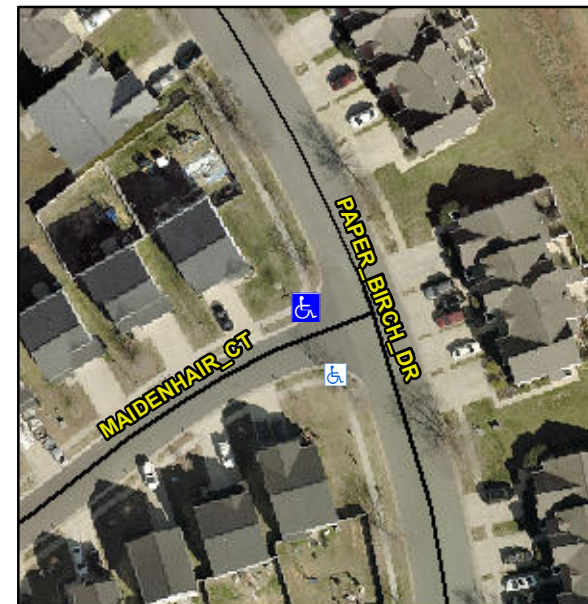
Compliance	Description	Data	Compliance	Description	Data
N/A	Ramp Length (in)	45.5	No	Ramp Slope (%)	9.2
Yes	Ramp Width (in)	48.0	Yes	Ramp XSlope (%)	1.7
N/A	Flare Type LT	N/A	N/A	Flare Type RT	N/A
N/A	Flare Slope LT (%)	N/A	N/A	Flare Slope RT (%)	N/A
N/A	Flare Traversable LT?	N/A	N/A	Flare Traversable RT?	N/A
N/A	Landing Length (in)	N/A	N/A	DWS Provided?	N/A
N/A	Landing Width (in)	N/A	N/A	DWS Contrast?	N/A
N/A	Landing Slope (%)	N/A	N/A	DWS Length (in)	N/A
N/A	Landing X Slope (%)	N/A	N/A	DWS Full Width?	N/A
N/A	Landing Curb? (Y/N)	N/A	N/A	DWS Offset (in)	N/A
N/A	Shared Landing?	N/A			
N/A	Gutter Ponding?	N/A	N/A	Gutter Slope (%)	N/A
N/A	Gutter Lip Ht (in)	N/A	N/A	Gutter X Slope (%)	N/A
N/A	Painted X Walk1?	No	N/A	Painted X Walk2?	N/A
	X Walk 1 Direction	To S		X Walk 2 Direction	N/A
N/A	X Walk 1 Width (in)	N/A	N/A	X Walk 2 Width (in)	N/A
	X Walk 1 Slope (%)	1.6		X Walk 2 Slope (%)	N/A
	X Walk 1 X Slope (%)	6.4		X Walk 2 X Slope (%)	N/A

N/A	Ramp inside XWalk1?	N/A	N/A	Ramp inside XWalk2?	N/A
	Road Slope (%)	N/A	N/A	Clear Space?	N/A
	Road X Slope (%)	N/A	N/A	Clear Space to XWalk (in)	N/A
N/A	Any Obstructions?	N/A	N/A	Storm Grate/Utility Hazard?	N/A
	Obstruction Type			Storm Grate/Utility Type	
		N/A			N/A
			Yes	Surface Condition? (G/P)	Good

Remove & Replace Entire Ramp.
