Access Compliance Report

Public Rights-of-Way

(Curb Ramps)

Intersection ID: 32271	Main Street: SPRINGWELL_ST	Cross Street: SULLIVAN_RIDGE_DR	Location: SW
ADA ID: CD85A2DEE2F2	Ramp Type: PerpDiag	Initial Pass/Fail: Fail	Overall Compliance: No
Severity Score: 22.5			
Codes/Mitigation Info/Possible Solution		Field Measurements/Component Compliance

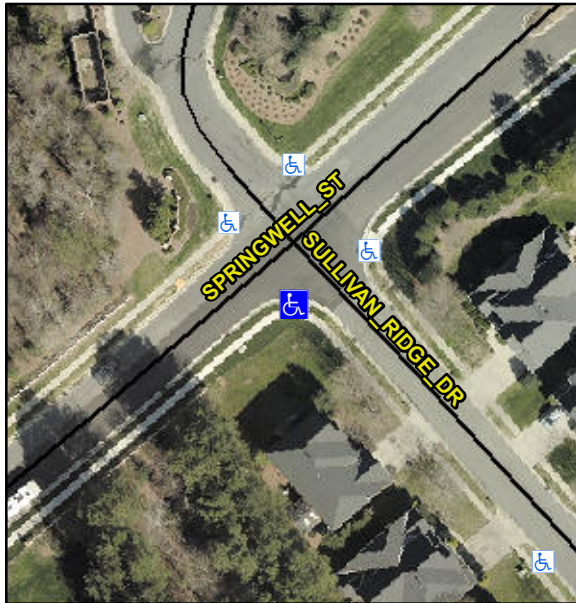
Compliance	Description	Data	Compliance	Description	Data
N/A	Ramp Length (in)	68.0	No	Ramp Slope (%)	10.5
No	Ramp Width (in)	43.0	No	Ramp XSlope (%)	3.8
N/A	Flare Type LT	N/A	N/A	Flare Type RT	N/A
N/A	Flare Slope LT (%)	N/A	N/A	Flare Slope RT (%)	N/A
N/A	Flare Traversable LT?	N/A	N/A	Flare Traversable RT?	N/A
N/A	Landing Length (in)	N/A	N/A	DWS Provided?	N/A
N/A	Landing Width (in)	N/A	N/A	DWS Contrast?	N/A
N/A	Landing Slope (%)	N/A	N/A	DWS Length (in)	N/A
N/A	Landing X Slope (%)	N/A	N/A	DWS Full Width?	N/A
N/A	Landing Curb? (Y/N)	N/A	N/A	DWS Offset (in)	N/A
N/A	Shared Landing?	N/A			
N/A	Gutter Ponding?	N/A	N/A	Gutter Slope (%)	N/A
N/A	Gutter Lip Ht (in)	N/A	N/A	Gutter X Slope (%)	N/A
N/A	Painted X Walk1?	No	N/A	Painted X Walk2?	No
	X Walk 1 Direction	To NE		X Walk 2 Direction	To NW
N/A	X Walk 1 Width (in)	N/A	N/A	X Walk 2 Width (in)	N/A
	X Walk 1 Slope (%)	4.6		X Walk 2 Slope (%)	0.2
	X Walk 1 X Slope (%)	0.7		X Walk 2 X Slope (%)	3.9

N/A	Ramp inside XWalk1?	N/A	N/A	Ramp inside XWalk2?	N/A
	Road Slope (%)	2.8	N/A	Clear Space?	N/A
	Road X Slope (%)	4.0	N/A	Clear Space to XWalk (in)	N/A
N/A	Any Obstructions?	N/A	N/A	Storm Grate/Utility Hazard?	N/A
	Obstruction Type			Storm Grate/Utility Type	
		N/A			N/A
			Yes	Surface Condition? (G/P)	Good

Possible Solutions:

Remove & Replace Curb Ramp With Two New Directional Ramps or Equivalent.
