# Access Compliance Report

## Public Rights-of-Way

### (Curb Ramps)

Intersection ID: N/A	Main Street: STEELE_CREEK_RD	Cross Street: N/A	Location: NE
ADA ID: CD88421864EE	Ramp Type: Perp	Initial Pass/Fail: Fail	Overall Compliance: No
		Severity Score: 12.5

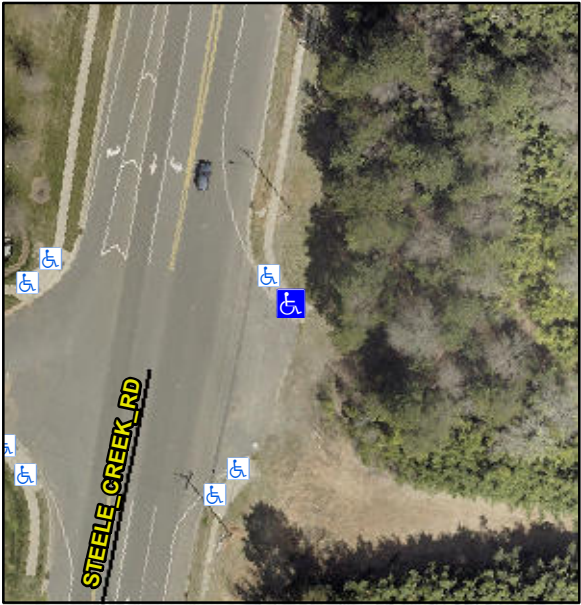
Possible Solutions:		<b>Compliance</b>	<b>Description</b>	<b>Data</b>
	<b>Remove &amp; Replace Entire Ramp.</b>		<b>No</b>	Ramp Length (in)	60.0
			<b>Yes</b>	Ramp Width (in)	60.0
			<b>N/A</b>	Flare Type LT	N/A
			<b>N/A</b>	Flare Slope LT (%)	N/A
			<b>N/A</b>	Flare Traversable LT?	N/A
			<b>N/A</b>	Landing Length (in)	N/A
			<b>N/A</b>	Landing Width (in)	N/A
			<b>N/A</b>	Landing Slope (%)	N/A
			<b>N/A</b>	Landing X Slope (%)	N/A
<p>Surveyor Notes:</p> <p><b>N/A</b></p> <p>PROW/ADA:</p> <p><b>Not Found, R304.2.2</b></p>			<b>N/A</b>	Flare Type RT	N/A
			<b>N/A</b>	Flare Slope RT (%)	N/A
			<b>N/A</b>	Flare Traversable RT?	N/A
			<b>N/A</b>	DWS Provided?	N/A
			<b>N/A</b>	DWS Contrast?	N/A
			<b>N/A</b>	DWS Length (in)	N/A
			<b>N/A</b>	DWS Full Width?	N/A
			<b>N/A</b>	DWS Offset (in)	N/A
			<b>N/A</b>	Shared Landing?	N/A

<b>N/A</b>	Gutter Ponding?	N/A
			<b>N/A</b>	Gutter Lip Ht (in)	N/A
			<b>No</b>	Painted X Walk1?	N/A
				X Walk 1 Direction	To S
			<b>N/A</b>	X Walk 1 Width (in)	N/A
			<b>0.5</b>	X Walk 1 Slope (%)	N/A
			<b>1.7</b>	X Walk 1 X Slope (%)	N/A
			<b>N/A</b>	Ramp inside XWalk1?	N/A
			<b>N/A</b>	Road Slope (%)	N/A
			<b>N/A</b>	Road X Slope (%)	N/A
			<b>N/A</b>	Any Obstructions?	N/A
Total Cost:		\$ 1850.00		Obstruction Type	
			<b>N/A</b>		N/A
			<b>Yes</b>	Surface Condition? (G/P)	Good
