## Access Compliance Report Public Rights-of-Way (Curb Ramps)

Intersection ID: 10018683Main Street: KARAM\_LNCross Street: N/ALocation:EADA ID: CD9700200660Ramp Type: PerpInitial Pass/Fail: FailOverall Compliance: NoSeverity Score:10

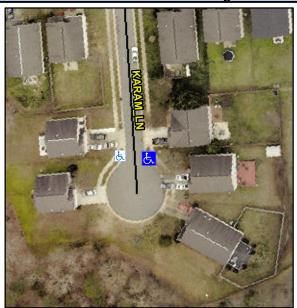
Field Measurements/Component Compliance							
Comp	liance Description	Data	Comp	liance Description	Data		
N/A	Ramp Length (in)	47.5	Yes	Ramp Slope (%)	7.1		
No	Ramp Width (in)	43.5	Yes	Ramp XSlope (%)	2.1		
N/A	Flare Type LT	N/A	N/A	Flare Type RT	N/A		
N/A	Flare Slope LT (%)	N/A	N/A	Flare Slope RT (%)	N/A		
N/A	Flare Traversable LT?	N/A	N/A	Flare Traversable RT	? <b>N/A</b>		
N/A	Landing Length (in)	N/A	N/A	DWS Provided?	N/A		
N/A	Landing Width (in)	N/A	N/A	DWS Contrast?	N/A		
N/A	Landing Slope (%)	N/A	N/A	DWS Length (in)	N/A		
N/A	Landing X Slope (%)	N/A	N/A	DWS Full Width?	N/A		
N/A	Landing Curb? (Y/N)	N/A	N/A	DWS Offset (in)	N/A		
N/A	Shared Landing?	N/A					
N/A	Gutter Ponding?	N/A	N/A	Gutter Slope (%)	N/A		
N/A	Gutter Lip Ht (in)	N/A	N/A	Gutter X Slope (%)	N/A		
N/A	Painted X Walk1?	No	N/A	Painted X Walk2?	N/A		
	X Walk 1 Direction	To W		X Walk 2 Direction	N/A		
N/A	X Walk 1 Width (in)	N/A	N/A	X Walk 2 Width (in)	N/A

X Walk 1 Slope (%)	2.3		X Walk 2 Slope (%)	N/A		
	X Walk 1 X Slope (%)	3.1		X Walk 2 X Slope (%)	N/A		
N/A	Ramp inside XWalk1?	N/A	N/A	Ramp inside XWalk2?	N/A		
	Road Slope (%)	N/A	N/A	Clear Space?	N/A		
	Road X Slope (%)	N/A	N/A	Clear Space to XWalk	(in) <b>N/A</b>		
N/A	Any Obstructions?	N/A	N/A	Storm Grate/Utility Ha	zard? N/A		
	Obstruction Type			Storm Grate/Utility Typ	pe		
		N/A			N/A		
			Yes	Surface Condition? (G	G/P) Good

OSSIDIE SOIULIOII		
Possible Solutions:	Compliance	
Remove & Replace Entire Ramp.	N/A	Ram
•	No	Ram
	N/A	Flare
	N/A	Flare
	N/A	Flare
	N/A	Lanc
Surveyor Notes:	N/A	Lanc
N/A	N/A	Lanc
	N/A	Lanc
	N/A	Lanc
	N/A	Shar
PROW/ADA:	N/A	Gutt
Not Found, R304.5.1	N/A	Gutt
	N/A	Pain
		X W
	N/A	X W
		X Wa
		X W
	N/A	Ram
		Roa
		Doo
