Access Compliance Report

Public Rights-of-Way

(Curb Ramps)

Intersection ID: 47670	Main Street: COLLINGHAM_DR	Cross Street: FENWAY_DR	Location: SW
ADA ID: CD98C11BB2F8	Ramp Type: BlendTrans1	Initial Pass/Fail: Fail	Overall Compliance: No
Severity Score: 8.75			
Codes/Mitigation Info/Possible Solution		Field Measurements/Component Compliance

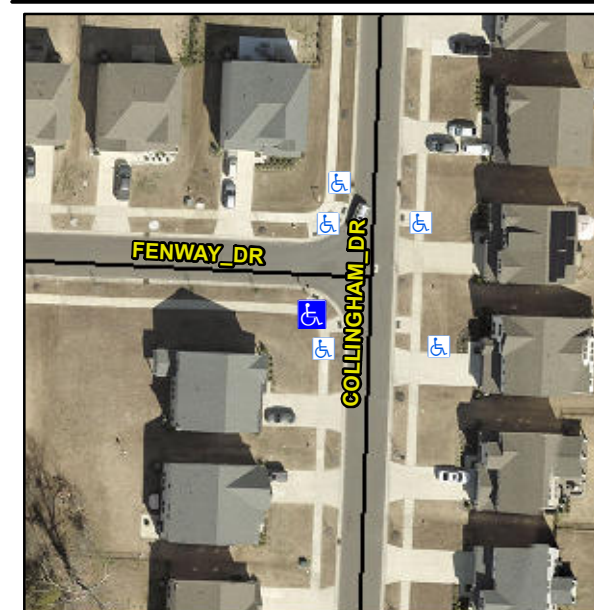
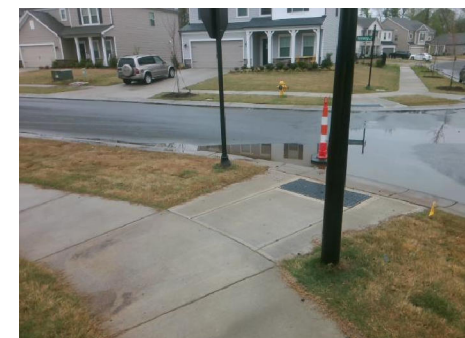
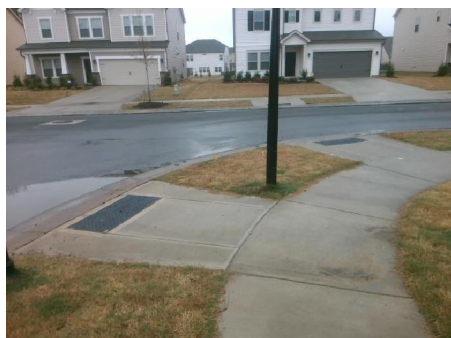
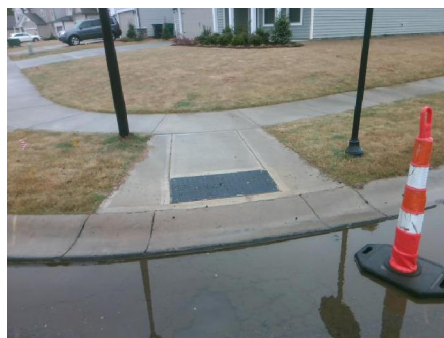
Not Found, R304.5.1

Compliance	Description	Data	Compliance	Description	Data
N/A	Ramp Length (in)	96.0	Yes	BlendTrans Slope (%)	4.7
No	Ramp Width (in)	41.0	Yes	BlendTrans XSlope (%)	1.2
N/A	Flare Type LT	N/A	N/A	Flare Type RT	N/A
N/A	Flare Slope LT (%)	N/A	N/A	Flare Slope RT (%)	N/A
N/A	Flare Traversable LT?	N/A	N/A	Flare Traversable RT?	N/A
N/A	Landing Length (in)	N/A	N/A	DWS Provided?	N/A
N/A	Landing Width (in)	N/A	N/A	DWS Contrast?	N/A
N/A	Landing Slope (%)	N/A	N/A	DWS Length (in)	N/A
N/A	Landing X Slope (%)	N/A	N/A	DWS Full Width?	N/A
N/A	Landing Curb? (Y/N)	N/A	N/A	DWS Offset (in)	N/A
N/A	Shared Landing?	N/A			
N/A	Gutter Ponding?	N/A	N/A	Gutter Slope (%)	N/A
N/A	Gutter Lip Ht (in)	1.0	N/A	Gutter X Slope (%)	N/A
N/A	Painted X Walk1?	No	N/A	Painted X Walk2?	N/A
	X Walk 1 Direction	To N		X Walk 2 Direction	N/A
	X Walk 1 Width (in)	N/A		X Walk 2 Width (in)	N/A
	X Walk 1 Slope (%)	1.1		X Walk 2 Slope (%)	N/A
	X Walk 1 X Slope (%)	3.1		X Walk 2 X Slope (%)	N/A

N/A	Ramp inside XWalk1?	N/A	N/A	Ramp inside XWalk2?	N/A
	Road Slope (%)	3.1		Clear Space?	N/A
	Road X Slope (%)	1.1	N/A	Clear Space to XWalk (in)	N/A
N/A	Any Obstructions?	N/A	N/A	Storm Grate/Utility Hazard?	N/A
	Obstruction Type			Storm Grate/Utility Type	
		N/A			N/A
			Yes	Surface Condition? (G/P)	Good
			No	Curb Slope (%)	6.9

Possible Solutions:

Remove & Replace Curb Ramp With Two New Directional Ramps or Equivalent.
