# Access Compliance Report

## Public Rights-of-Way

| Intersection ID: 45518 | Main Street: COTTON_PRESS_RD | Cross Street: MEADOW_BOTTOM_RD | Location: S |
| ADA ID: CDA166436F01 | Ramp Type: PerpDiag | Initial Pass/Fail: Fail | Overall Compliance: No |

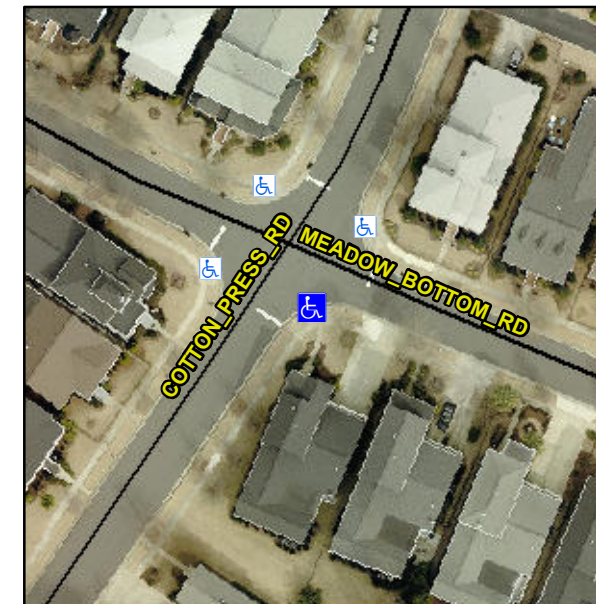
**Not Found, R304.5.1, R304.2.2**

| Compliance | Description | Data | Compliance | Description | Data |
|---|---|---|---|---|---|
| N/A | Ramp Length (in) | 72.0 | No | Ramp Slope (%) | 11.1 |
| No | Ramp Width (in) | 35.0 | Yes | Ramp XSlope (%) | 0.2 |

**Remove & Replace Curb Ramp With Two New Directional Ramps or Equivalent.**

Total Cost: \$ 3200.00
