| Intersection ID: 48135 | Main Street: HIGHLAND_CREEK_PY | Cross Street: SQUIRREL_TRAIL_LN | Location: | NW |
| ADA ID: CDA2E5B865C4 | Ramp Type: Perp | Initial Pass/Fail: Fail | Overall Compliance: No | Severity Score: 12.5 |

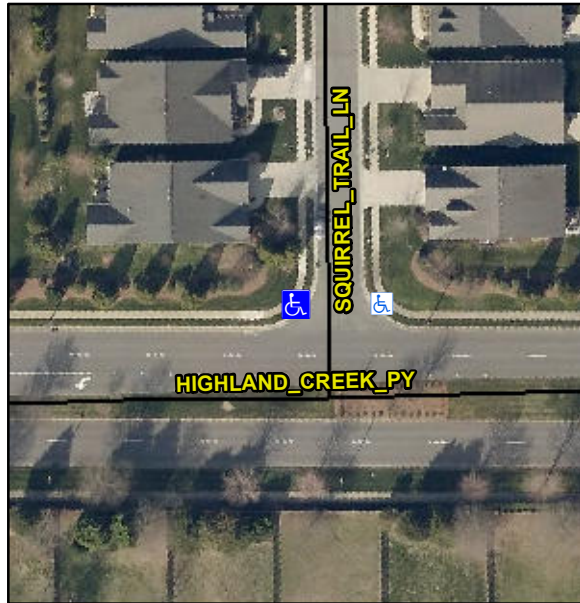
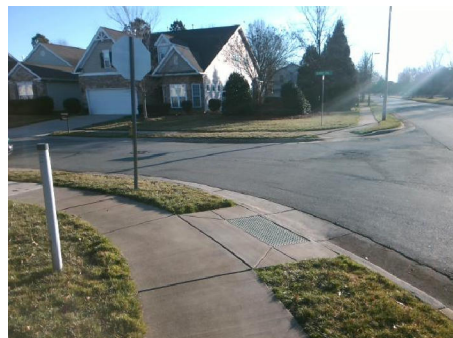
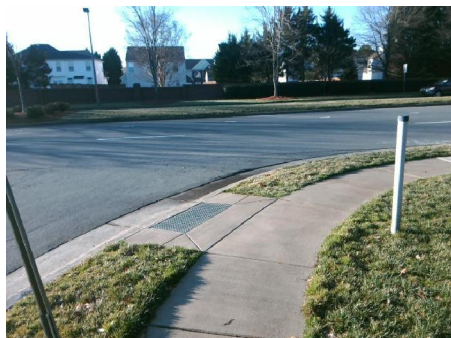
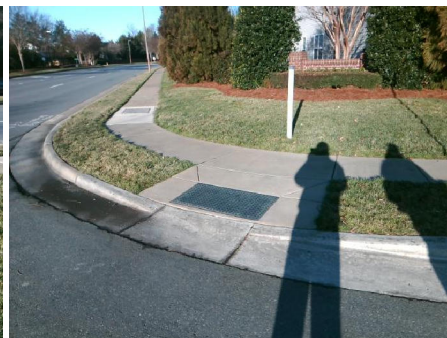
Not Found, R304.2.2

| Compliance | Description | Data | Compliance | Description | Data |
|---|---|---|---|---|---|
| N/A | Ramp Length (in) | 49.0 | No | Ramp Slope (%) | 10.2 |
| Yes | Ramp Width (in) | 48.0 | Yes | Ramp XSlope (%) | 0.3 |
| | | | Yes | Surface Condition? (G/P) | Good |

Possible Solutions:

Remove & Replace Entire Ramp.

Total Cost: \$ 1850.00
