## Access Compliance Report Public Rights-of-Way (Curb Ramps)

Intersection ID: N/AMain Street:FINCHER\_FARM\_RDCross Street: N/ALocation:SWADA ID: CDA973E34F97Ramp Type:PerpDiagInitial Pass/Fail:FailOverall Compliance: NoSeverity Score:25

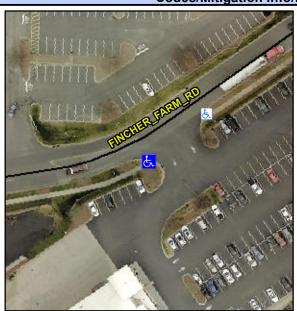
Not Found, R304.5.3

| Field Measurements/Component Compliance | | | | | | |
|---|---|---|---|---|---|---|
| Yes | Ramp Width (in) | 48.0 | No | Ram | XSlope (%) | 7.5 |

Remove & Replace Curb Ramp With
Two New Directional Ramps or
Equivalent.
