# Access Compliance Report

## Public Rights-of-Way

### (Curb Ramps)

| Intersection ID: 10445 | Main Street: E_34TH_ST | Cross Street: N_MCDOWELL_ST | Location: N |

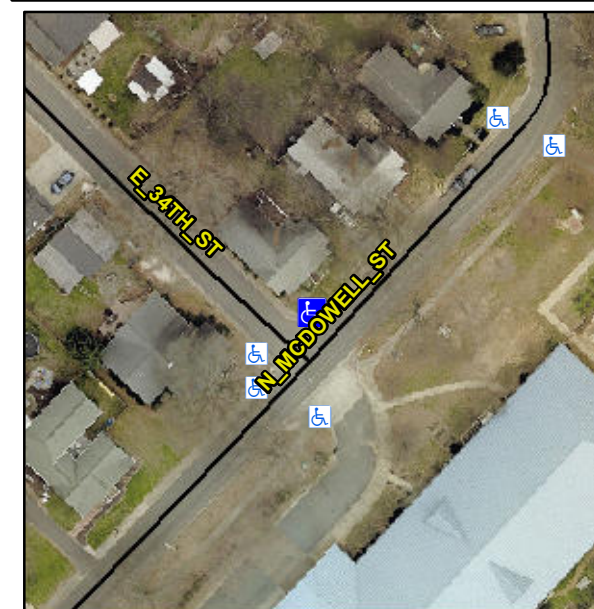
| ADA ID: CDBC7C6E64C4 | Ramp Type: PerpDiag | Initial Pass/Fail: Fail | Overall Compliance: No |
| Severity Score: 25 | | | |

PROW/ADA:

**R304.2.2**

| Compliance | Description | Data | Compliance | Description | Data |
|---|---|---|---|---|---|
| N/A | Ramp Length (in) | 55.0 | No | Ramp Slope (%) | 16.7 |

Possible Solutions:

**Remove & Replace Curb Ramp With Two New Directional Ramps or Equivalent.**

Total Cost:

**\$ 3200.00**
