# Access Compliance Report

## Public Rights-of-Way

### (Curb Ramps)

Intersection ID: 12809	Main Street: N_MCDOWELL_ST	Cross Street: E_7TH_ST	Location:	N
ADA ID: CDBD1DBD7E8B	Ramp Type: PerpDiag	Initial Pass/Fail: Fail	Overall Compliance: No	Severity Score: 22.5
Codes/Mitigation Info/Possible Solution		Field Measurements/Component Compliance

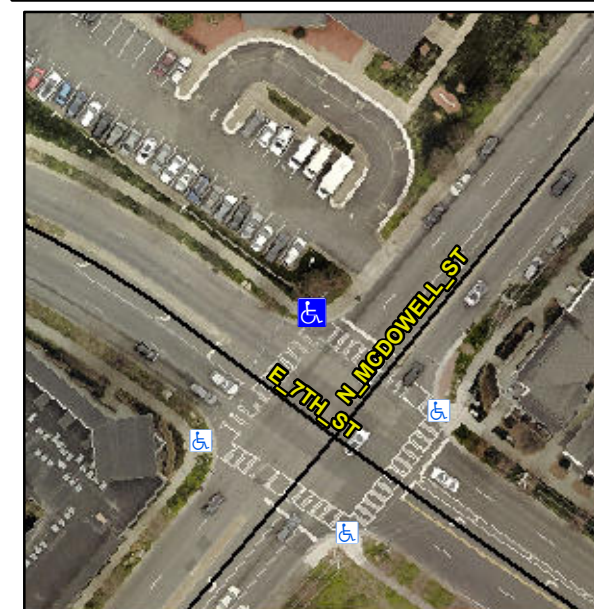
**Not Found, R304.5.1, R304.2.2, R304.5.3**

Compliance	Description	Data	Compliance	Description	Data
N/A	Ramp Length (in)	62.0	No	Ramp Slope (%)	8.6
No	Ramp Width (in)	41.0	No	Ramp XSlope (%)	2.9
N/A	Flare Type LT	N/A	N/A	Flare Type RT	N/A
N/A	Flare Slope LT (%)	N/A	N/A	Flare Slope RT (%)	N/A
N/A	Flare Traversable LT?	N/A	N/A	Flare Traversable RT?	N/A
N/A	Landing Length (in)	N/A	N/A	DWS Provided?	N/A
N/A	Landing Width (in)	N/A	N/A	DWS Contrast?	N/A
N/A	Landing Slope (%)	N/A	N/A	DWS Length (in)	N/A
N/A	Landing X Slope (%)	N/A	N/A	DWS Full Width?	N/A
N/A	Landing Curb? (Y/N)	N/A	N/A	DWS Offset (in)	N/A
N/A	Shared Landing?	N/A			
N/A	Gutter Ponding?	N/A	N/A	Gutter Slope (%)	N/A
N/A	Gutter Lip Ht (in)	N/A	N/A	Gutter X Slope (%)	N/A
N/A	Painted X Walk1?	Yes	N/A	Painted X Walk2?	Yes
	X Walk 1 Direction	To SW		X Walk 2 Direction	To SE
N/A	X Walk 1 Width (in)	112.0	N/A	X Walk 2 Width (in)	113.0
	X Walk 1 Slope (%)	0.2		X Walk 2 Slope (%)	0.1
	X Walk 1 X Slope (%)	2.9		X Walk 2 X Slope (%)	1.9

N/A	Ramp inside XWalk1?	Yes	N/A	Ramp inside XWalk2?	Yes
	Road Slope (%)	0.0	N/A	Clear Space?	N/A
	Road X Slope (%)	3.0	N/A	Clear Space to XWalk (in)	N/A
N/A	Any Obstructions?	N/A	N/A	Storm Grate/Utility Hazard?	N/A
	Obstruction Type			Storm Grate/Utility Type	
		N/A			N/A
		Yes		Surface Condition? (G/P)	Good

**Remove & Replace Curb Ramp With Two New Directional Ramps or Equivalent.**
