# Access Compliance Report

## Public Rights-of-Way

| Intersection ID: 10026093 | Main Street: ENGLAND_ST | Cross Street: N/A | Location: NE |
| ADA ID: CDC8618EE3D1 | Ramp Type: PerpDiag | Initial Pass/Fail: Fail | Overall Compliance: No |

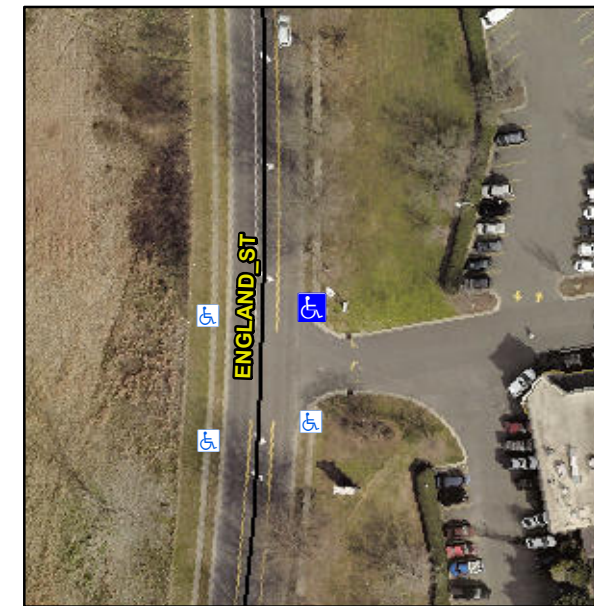
| | | Severity Score: 12.5 | |

| Compliance | Description | Data | Compliance | Description | Data |
|---|---|---|---|---|---|
| N/A | Ramp Length (in) | 96.0 | Yes | Ramp Slope (%) | 8.3 |
| Yes | Ramp Width (in) | 48.0 | No | Ramp XSlope (%) | 5.8 |

**Remove & Replace Curb Ramp With Two New Directional Ramps or Equivalent.**

**R304.5.3**

Total Cost: \$ 3200.00
