Access Compliance Report

Public Rights-of-Way

(Curb Ramps)

Intersection ID: 21797	Main Street: GALLERIA_BV	Cross Street: MONROE_RD	Location: NW
ADA ID: CDCC1390CCD1	Ramp Type: Perp	Initial Pass/Fail: Fail	Overall Compliance: No
Severity Score: 33.75			
Codes/Mitigation Info/Possible Solution		Field Measurements/Component Compliance

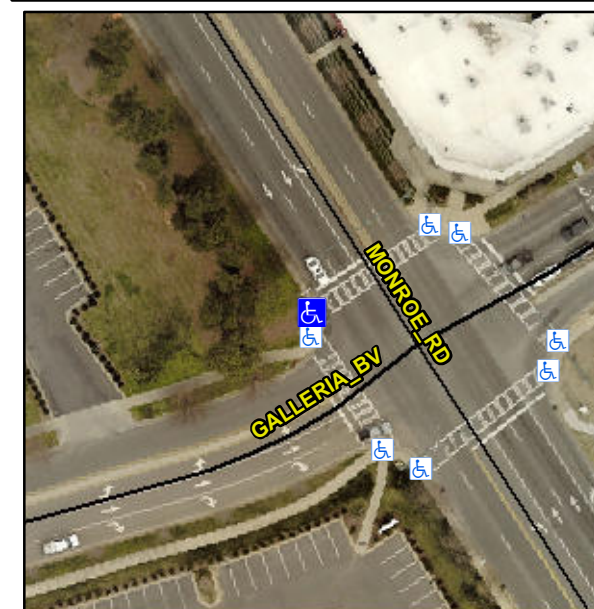
R304.5.1, R304.2.2, R304.5.3

Compliance	Description	Data	Compliance	Description	Data
N/A	Ramp Length (in)	36.0	No	Ramp Slope (%)	8.4
No	Ramp Width (in)	40.0	No	Ramp XSlope (%)	5.8
N/A	Flare Type LT	N/A	N/A	Flare Type RT	N/A
N/A	Flare Slope LT (%)	N/A	N/A	Flare Slope RT (%)	N/A
N/A	Flare Traversable LT?	N/A	N/A	Flare Traversable RT?	N/A
N/A	Landing Length (in)	N/A	N/A	DWS Provided?	N/A
N/A	Landing Width (in)	N/A	N/A	DWS Contrast?	N/A
N/A	Landing Slope (%)	N/A	N/A	DWS Length (in)	N/A
N/A	Landing X Slope (%)	N/A	N/A	DWS Full Width?	N/A
N/A	Landing Curb? (Y/N)	N/A	N/A	DWS Offset (in)	N/A
N/A	Shared Landing?	N/A			
N/A	Gutter Ponding?	N/A	N/A	Gutter Slope (%)	N/A
N/A	Gutter Lip Ht (in)	N/A	N/A	Gutter X Slope (%)	N/A
N/A	Painted X Walk1?	Yes	N/A	Painted X Walk2?	N/A
	X Walk 1 Direction	To NE		X Walk 2 Direction	N/A
N/A	X Walk 1 Width (in)	96.0	N/A	X Walk 2 Width (in)	N/A
	X Walk 1 Slope (%)	5.4		X Walk 2 Slope (%)	N/A
	X Walk 1 X Slope (%)	0.5		X Walk 2 X Slope (%)	N/A

N/A	Ramp inside XWalk1?	Yes	N/A	Ramp inside XWalk2?	N/A
	Road Slope (%)	N/A	N/A	Clear Space?	N/A
	Road X Slope (%)	N/A	N/A	Clear Space to XWalk (in)	N/A
N/A	Any Obstructions?	N/A	N/A	Storm Grate/Utility Hazard?	N/A
	Obstruction Type			Storm Grate/Utility Type	
		N/A			N/A
		Yes		Surface Condition? (G/P)	Good

Possible Solutions:

Remove & Replace Entire Ramp.
