# Access Compliance Report

## Public Rights-of-Way

### (Curb Ramps)

Intersection ID: 11499	Main Street: TIMBERTOP_LN	Cross Street: VERONICA_DR	Location: SW
ADA ID: CDCD90C5792B	Ramp Type: PerpDiag	Initial Pass/Fail: Fail	Overall Compliance: No
		Severity Score: 10

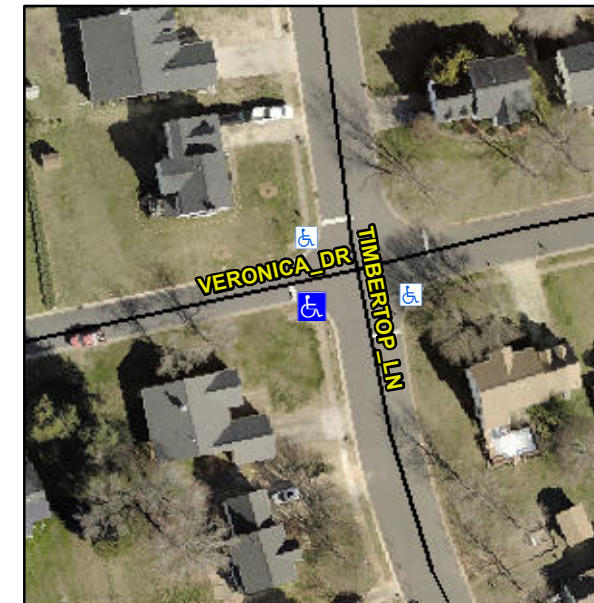
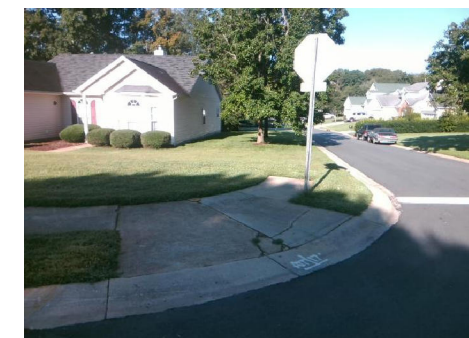
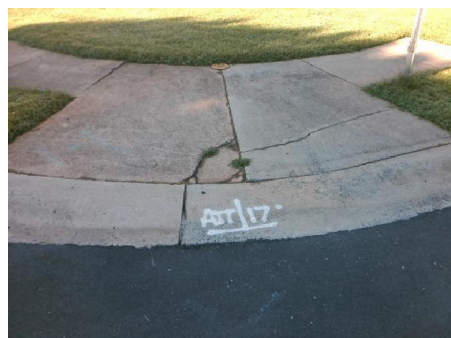
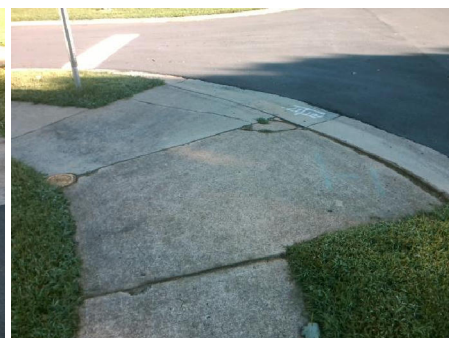
**Not Found, R304.5.1, R304.5.3**

Compliance	Description	Data	Compliance	Description	Data
N/A	Ramp Length (in)	94.5	Yes	Ramp Slope (%)	5.9
No	Ramp Width (in)	47.0	No	Ramp XSlope (%)	2.9
N/A	Flare Type LT	N/A	N/A	Flare Type RT	N/A
N/A	Flare Slope LT (%)	N/A	N/A	Flare Slope RT (%)	N/A
N/A	Flare Traversable LT?	N/A	N/A	Flare Traversable RT?	N/A
N/A	Landing Length (in)	N/A	N/A	DWS Provided?	N/A
N/A	Landing Width (in)	N/A	N/A	DWS Contrast?	N/A
N/A	Landing Slope (%)	N/A	N/A	DWS Length (in)	N/A
N/A	Landing X Slope (%)	N/A	N/A	DWS Full Width?	N/A
N/A	Landing Curb? (Y/N)	N/A	N/A	DWS Offset (in)	N/A
N/A	Shared Landing?	N/A			
N/A	Gutter Ponding?	N/A	N/A	Gutter Slope (%)	N/A
N/A	Gutter Lip Ht (in)	N/A	N/A	Gutter X Slope (%)	N/A
N/A	Painted X Walk1?	No	N/A	Painted X Walk2?	No
	X Walk 1 Direction	To E		X Walk 2 Direction	To N
N/A	X Walk 1 Width (in)	N/A	N/A	X Walk 2 Width (in)	N/A
	X Walk 1 Slope (%)	3.5		X Walk 2 Slope (%)	1.6
	X Walk 1 X Slope (%)	2.4		X Walk 2 X Slope (%)	3.0

N/A	Ramp inside XWalk1?	N/A	N/A	Ramp inside XWalk2?	N/A
	Road Slope (%)	2.5	N/A	Clear Space?	N/A
	Road X Slope (%)	4.4	N/A	Clear Space to XWalk (in)	N/A
N/A	Any Obstructions?	N/A	N/A	Storm Grate/Utility Hazard?	N/A
	Obstruction Type			Storm Grate/Utility Type	
		N/A			N/A
			Yes	Surface Condition? (G/P)	Good

**Remove & Replace Curb Ramp With Two New Directional Ramps or Equivalent.**
