# Access Compliance Report

## Public Rights-of-Way

### (Curb Ramps)

Intersection ID: 23447	Main Street: BRACKENBURY_LN	Cross Street: ALEXANDER_RD	Location: W
ADA ID: CDD2F6C546AE	Ramp Type: Perp	Initial Pass/Fail: Fail	Overall Compliance: No
Severity Score: 21.25			
Codes/Mitigation Info/Possible Solution		Field Measurements/Component Compliance

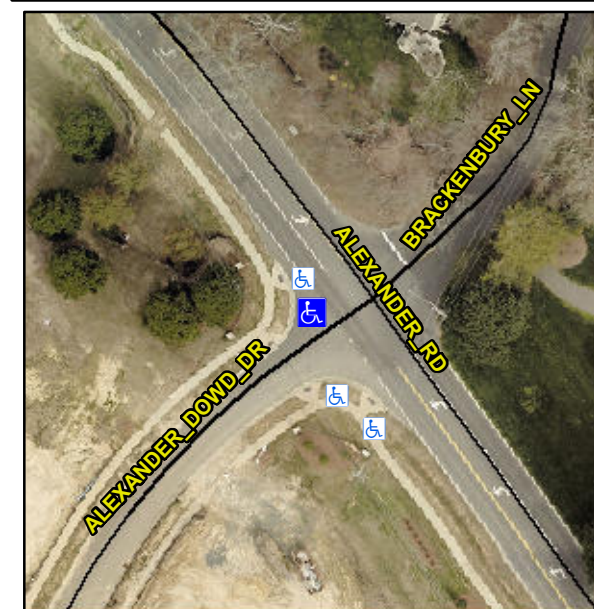
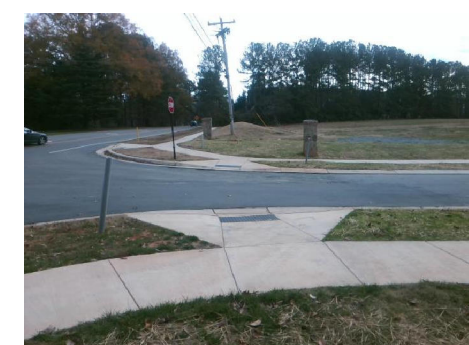
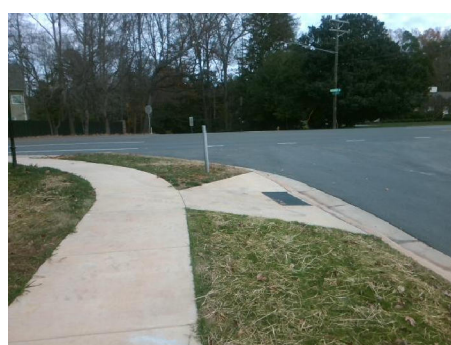
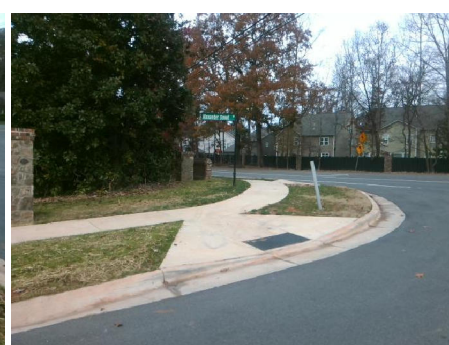
Compliance	Description	Data	Compliance	Description	Data
N/A	Ramp Length (in)	96.0	No	Ramp Slope (%)	8.6
No	Ramp Width (in)	47.5	Yes	Ramp XSlope (%)	1.6
N/A	Flare Type LT	N/A	N/A	Flare Type RT	N/A
N/A	Flare Slope LT (%)	N/A	N/A	Flare Slope RT (%)	N/A
N/A	Flare Traversable LT?	N/A	N/A	Flare Traversable RT?	N/A
N/A	Landing Length (in)	N/A	N/A	DWS Provided?	N/A
N/A	Landing Width (in)	N/A	N/A	DWS Contrast?	N/A
N/A	Landing Slope (%)	N/A	N/A	DWS Length (in)	N/A
N/A	Landing X Slope (%)	N/A	N/A	DWS Full Width?	N/A
N/A	Landing Curb? (Y/N)	N/A	N/A	DWS Offset (in)	N/A
N/A	Shared Landing?	N/A			
N/A	Gutter Ponding?	N/A	N/A	Gutter Slope (%)	N/A
N/A	Gutter Lip Ht (in)	N/A	N/A	Gutter X Slope (%)	N/A
N/A	Painted X Walk1?	No	N/A	Painted X Walk2?	N/A
	X Walk 1 Direction	To S		X Walk 2 Direction	N/A
N/A	X Walk 1 Width (in)	N/A	N/A	X Walk 2 Width (in)	N/A
	X Walk 1 Slope (%)	2.6		X Walk 2 Slope (%)	N/A
	X Walk 1 X Slope (%)	4.9		X Walk 2 X Slope (%)	N/A

N/A	Ramp inside XWalk1?	N/A	N/A	Ramp inside XWalk2?	N/A
	Road Slope (%)	N/A	N/A	Clear Space?	N/A
	Road X Slope (%)	N/A	N/A	Clear Space to XWalk (in)	N/A
N/A	Any Obstructions?	N/A	N/A	Storm Grate/Utility Hazard?	N/A
	Obstruction Type			Storm Grate/Utility Type	
		N/A			N/A
			Yes	Surface Condition? (G/P)	Good

Possible Solutions:

**Remove & Replace Entire Ramp.**

**R304.5.1, R304.2.2**

**\$ 1850.00**
