Intersection ID: 52526	Main Street: MCCLINTOCK_RD	Cross Street: ANDREWS_LN	Location:	W
ADA ID: CDDF98E5D9FB	Ramp Type: Perp	Initial Pass/Fail: Fail	Overall Compliance: No	Severity Score: 10

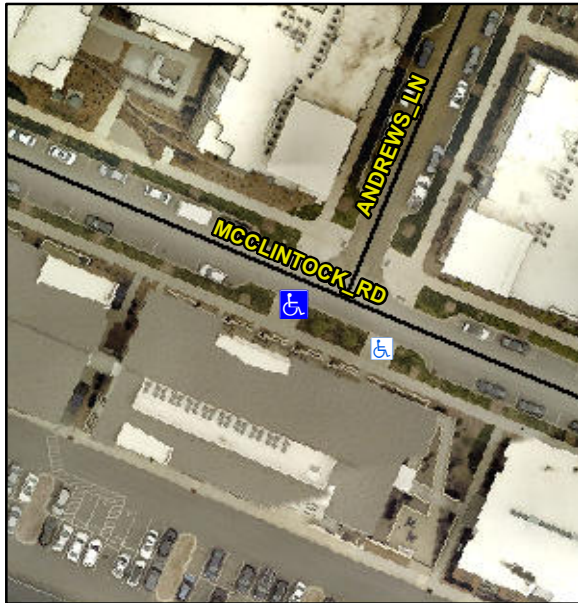
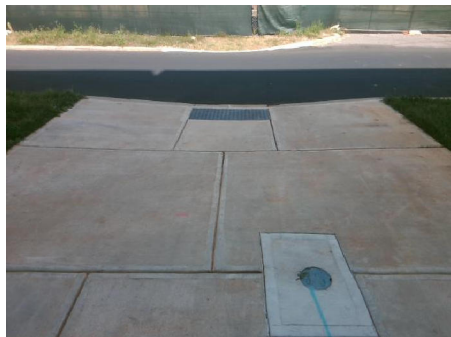
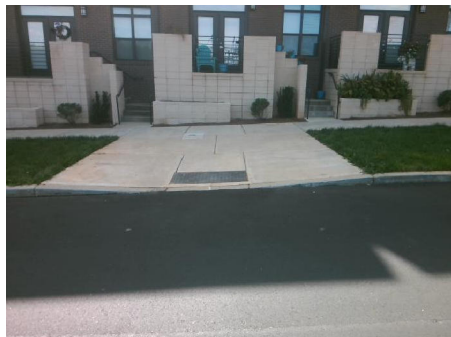
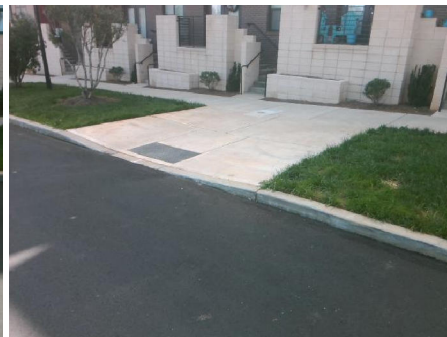
R304.5.1

Possible Solutions:			Compliance	Description	Data	Compliance	Description	Data		
Remove & Replace Entire Ramp.			N/A	Ramp Length (in)	77.0	Yes	Ramp Slope (%)	6.0		
			No	Ramp Width (in)	46.5	Yes	Ramp XSlope (%)	4.7		
			N/A	Flare Type LT	N/A	N/A	Flare Type RT	N/A		
			N/A	Flare Slope LT (%)	N/A	N/A	Flare Slope RT (%)	N/A		
			N/A	Flare Traversable LT?	N/A	N/A	Flare Traversable RT?	N/A		
			N/A	Landing Length (in)	N/A	N/A	DWS Provided?	N/A		
			N/A	Landing Width (in)	N/A	N/A	DWS Contrast?	N/A		
			N/A	Landing Slope (%)	N/A	N/A	DWS Length (in)	N/A		
			N/A	Landing X Slope (%)	N/A	N/A	DWS Full Width?	N/A		
			N/A	Landing Curb? (Y/N)	N/A	N/A	DWS Offset (in)	N/A		
Surveyor Notes: N/A			N/A	Shared Landing?	N/A					
			N/A	Gutter Ponding?	N/A	N/A	Gutter Slope (%)	N/A		
			N/A	Gutter Lip Ht (in)	N/A	N/A	Gutter X Slope (%)	N/A		
			N/A	Painted X Walk1?	No	N/A	Painted X Walk2?	N/A		
				X Walk 1 Direction	To NE		X Walk 2 Direction	N/A

N/A	X Walk 1 Width (in)	N/A	N/A	X Walk 2 Width (in)	N/A		
				X Walk 1 Slope (%)	1.2		X Walk 2 Slope (%)	N/A		
				X Walk 1 X Slope (%)	4.8		X Walk 2 X Slope (%)	N/A		
			N/A	Ramp inside XWalk1?	N/A	N/A	Ramp inside XWalk2?	N/A		
				Road Slope (%)	N/A	N/A	Clear Space?	N/A		
PROW/ADA: R304.5.1				Road X Slope (%)	N/A	N/A	Clear Space to XWalk (in)	N/A		
			N/A	Any Obstructions?	N/A	N/A	Storm Grate/Utility Hazard?	N/A		
				Obstruction Type			Storm Grate/Utility Type			
					N/A			N/A		
						Yes	Surface Condition? (G/P)	Good		
			Total Cost: \$ 1850.00

Remove & Replace Entire Ramp.
