Access Compliance Report

Public Rights-of-Way

(Curb Ramps)

Intersection ID: 14486	Main Street: MAIN_ST	Cross Street: AVANT_ST	Location: S
ADA ID: CDF046EA627D	Ramp Type: PerpDiag	Initial Pass/Fail: Fail	Overall Compliance: No
		Severity Score: 17.5

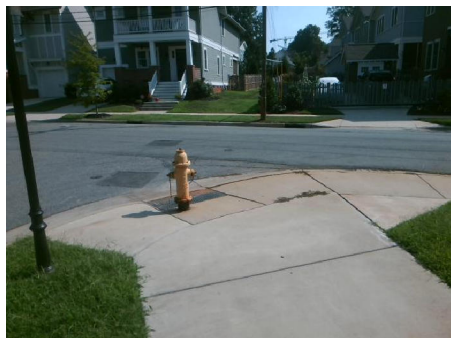
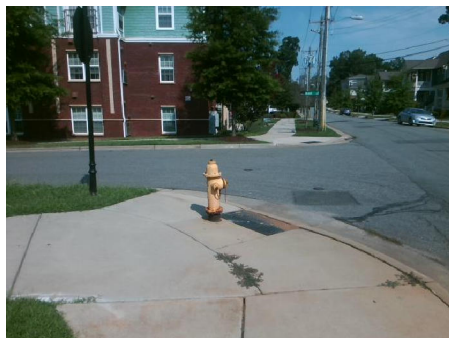
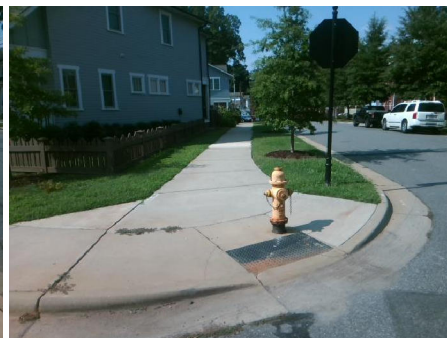
Not Found, R304.5.1

Compliance	Description	Data	Compliance	Description	Data
N/A	Ramp Length (in)	61.0	Yes	Ramp Slope (%)	7.7
No	Ramp Width (in)	35.0	Yes	Ramp XSlope (%)	0.7
N/A	Flare Type LT	N/A	N/A	Flare Type RT	N/A
N/A	Flare Slope LT (%)	N/A	N/A	Flare Slope RT (%)	N/A
N/A	Flare Traversable LT?	N/A	N/A	Flare Traversable RT?	N/A
N/A	Landing Length (in)	N/A	N/A	DWS Provided?	N/A
N/A	Landing Width (in)	N/A	N/A	DWS Contrast?	N/A
N/A	Landing Slope (%)	N/A	N/A	DWS Length (in)	N/A
N/A	Landing X Slope (%)	N/A	N/A	DWS Full Width?	N/A
N/A	Landing Curb? (Y/N)	N/A	N/A	DWS Offset (in)	N/A
N/A	Shared Landing?	N/A			
N/A	Gutter Ponding?	N/A	N/A	Gutter Slope (%)	N/A
N/A	Gutter Lip Ht (in)	N/A	N/A	Gutter X Slope (%)	N/A
N/A	Painted X Walk1?	No	N/A	Painted X Walk2?	No
	X Walk 1 Direction	To NE		X Walk 2 Direction	To NW
N/A	X Walk 1 Width (in)	N/A	N/A	X Walk 2 Width (in)	N/A
	X Walk 1 Slope (%)	4.1		X Walk 2 Slope (%)	0.9
	X Walk 1 X Slope (%)	1.4		X Walk 2 X Slope (%)	1.1

N/A	Ramp inside XWalk1?	N/A	N/A	Ramp inside XWalk2?	N/A
	Road Slope (%)	1.2	N/A	Clear Space?	N/A
	Road X Slope (%)	3.5	N/A	Clear Space to XWalk (in)	N/A
N/A	Any Obstructions?	N/A	N/A	Storm Grate/Utility Hazard?	N/A
	Obstruction Type			Storm Grate/Utility Type	
		N/A			N/A
			Yes	Surface Condition? (G/P)	Good

Remove & Replace Curb Ramp With Two New Directional Ramps or Equivalent.
