Access Compliance Report

Public Rights-of-Way

(Curb Ramps)

Intersection ID: 11972	Main Street: N_POPLAR_ST	Cross Street: W_5TH_ST	Location: W
ADA ID: CDF973D6A000	Ramp Type: PerpDiag	Initial Pass/Fail: Fail	Overall Compliance: No
			Severity Score: 10

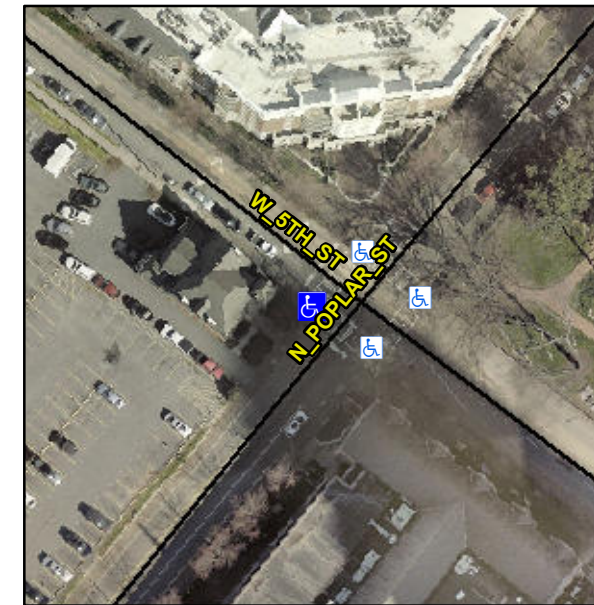
Not Found, R304.5.1, R304.5.3

Compliance	Description	Data	Compliance	Description	Data
N/A	Ramp Length (in)	64.0	Yes	Ramp Slope (%)	8.1
No	Ramp Width (in)	44.0	No	Ramp XSlope (%)	4.8
N/A	Flare Type LT	N/A	N/A	Flare Type RT	N/A
N/A	Flare Slope LT (%)	N/A	N/A	Flare Slope RT (%)	N/A
N/A	Flare Traversable LT?	N/A	N/A	Flare Traversable RT?	N/A
N/A	Landing Length (in)	N/A	N/A	DWS Provided?	N/A
N/A	Landing Width (in)	N/A	N/A	DWS Contrast?	N/A
N/A	Landing Slope (%)	N/A	N/A	DWS Length (in)	N/A
N/A	Landing X Slope (%)	N/A	N/A	DWS Full Width?	N/A
N/A	Landing Curb? (Y/N)	N/A	N/A	DWS Offset (in)	N/A
N/A	Shared Landing?	N/A			
N/A	Gutter Ponding?	N/A	N/A	Gutter Slope (%)	N/A
N/A	Gutter Lip Ht (in)	N/A	N/A	Gutter X Slope (%)	N/A
N/A	Painted X Walk1?	Yes	N/A	Painted X Walk2?	Yes
	X Walk 1 Direction	To SE		X Walk 2 Direction	To NE
N/A	X Walk 1 Width (in)	112.0	N/A	X Walk 2 Width (in)	113.0
	X Walk 1 Slope (%)	3.1		X Walk 2 Slope (%)	1.4
	X Walk 1 X Slope (%)	1.4		X Walk 2 X Slope (%)	1.8

N/A	Ramp inside XWalk1?	Yes	N/A	Ramp inside XWalk2?	Yes
	Road Slope (%)	1.6	N/A	Clear Space?	N/A
	Road X Slope (%)	0.6	N/A	Clear Space to XWalk (in)	N/A
N/A	Any Obstructions?	N/A	N/A	Storm Grate/Utility Hazard?	N/A
	Obstruction Type			Storm Grate/Utility Type	
		N/A			N/A
			Yes	Surface Condition? (G/P)	Good

Remove & Replace Curb Ramp With Two New Directional Ramps or Equivalent.
