Access Compliance Report

(Curb Ramps)

Intersection ID: 42359	Main Street: HERON_GLEN_DR	Cross Street: WRENS_NEST_LN	Location: E
ADA ID: CDFE37101788	Ramp Type: PerpDiag	Initial Pass/Fail: Fail	Overall Compliance: No
Severity Score: 25			
Codes/Mitigation Info/Possible Solution		Field Measurements/Component Compliance

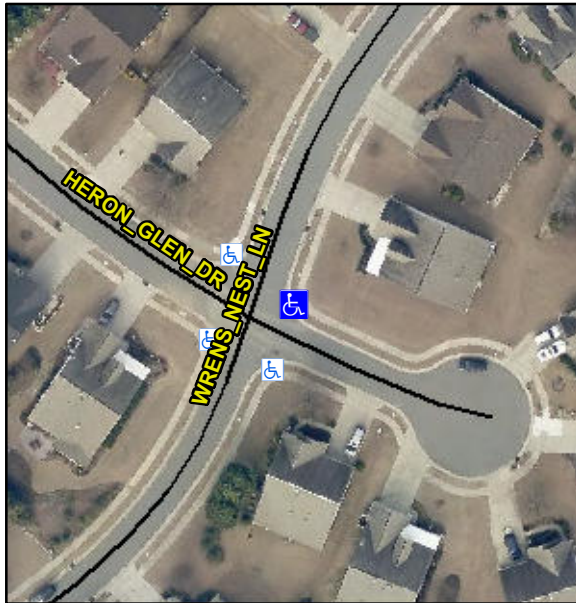
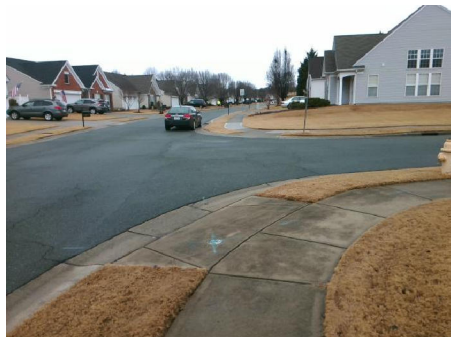
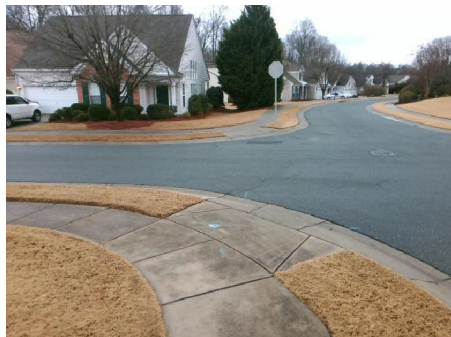
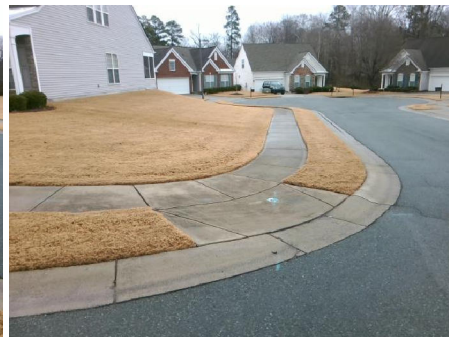
Compliance	Description	Data	Compliance	Description	Data
N/A	Ramp Length (in)	46.0	Yes	Ramp Slope (%)	5.0
Yes	Ramp Width (in)	70.0	No	Ramp XSlope (%)	7.7
N/A	Flare Type LT	N/A	N/A	Flare Type RT	N/A
N/A	Flare Slope LT (%)	N/A	N/A	Flare Slope RT (%)	N/A
N/A	Flare Traversable LT?	N/A	N/A	Flare Traversable RT?	N/A
N/A	Landing Length (in)	N/A	N/A	DWS Provided?	N/A
N/A	Landing Width (in)	N/A	N/A	DWS Contrast?	N/A
N/A	Landing Slope (%)	N/A	N/A	DWS Length (in)	N/A
N/A	Landing X Slope (%)	N/A	N/A	DWS Full Width?	N/A
N/A	Landing Curb? (Y/N)	N/A	N/A	DWS Offset (in)	N/A
N/A	Shared Landing?	N/A			
N/A	Gutter Ponding?	N/A	N/A	Gutter Slope (%)	N/A
N/A	Gutter Lip Ht (in)	1.0	N/A	Gutter X Slope (%)	N/A
N/A	Painted X Walk1?	No	N/A	Painted X Walk2?	No
	X Walk 1 Direction	To NW		X Walk 2 Direction	To SW
N/A	X Walk 1 Width (in)	N/A	N/A	X Walk 2 Width (in)	N/A
	X Walk 1 Slope (%)	5.5		X Walk 2 Slope (%)	1.9
	X Walk 1 X Slope (%)	1.2		X Walk 2 X Slope (%)	3.1

N/A	Ramp inside XWalk1?	N/A	N/A	Ramp inside XWalk2?	N/A
	Road Slope (%)	6.3	N/A	Clear Space?	N/A
	Road X Slope (%)	4.0	N/A	Clear Space to XWalk (in)	N/A
N/A	Any Obstructions?	N/A	N/A	Storm Grate/Utility Hazard?	N/A
	Obstruction Type			Storm Grate/Utility Type	
		N/A			N/A
		Yes		Surface Condition? (G/P)	Good

Remove & Replace Curb Ramp With Two New Directional Ramps or Equivalent.
